Preliminary Investigation for Determination of an Area in Need of Redevelopment and Rehabilitation

Block 134, Lots 1-7 & 26-28; Block 135, Lots 1-8 & 13-14; Blocks 136-140 (All Lots)

Prepared For:
Borough of Chatham
Morris County, New Jersey
July 2021

Prepared By:
DMR Architects

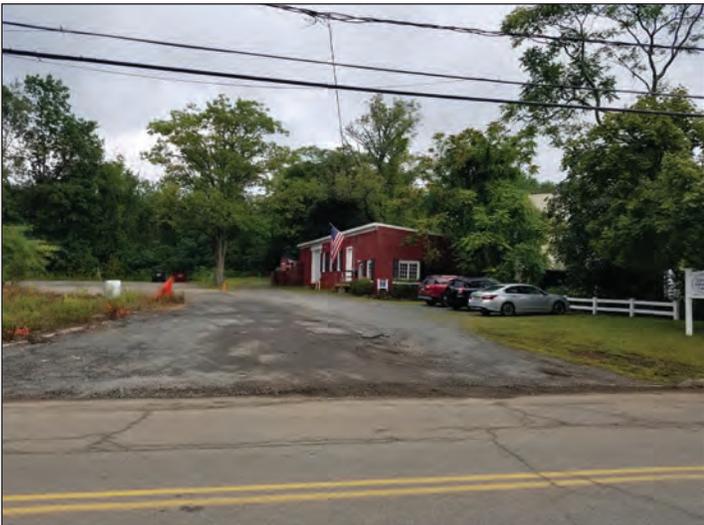
The surfaces of the parking and circulation areas are significantly deteriorated throughout the property but particularly near the site entrance. This is likely due to a combination of heavy and frequent truck traffic in and out of the site and stormwater accumulation toward the lowest lying areas of the lot that is exacerbated by the lack of drainage in the middle of the lot. See Figures 4, 5, and 7.

Figure 4: Worn out pavement and gravel driveway, muddy from recent rain. Tire tracks visible in lawn, to the right.

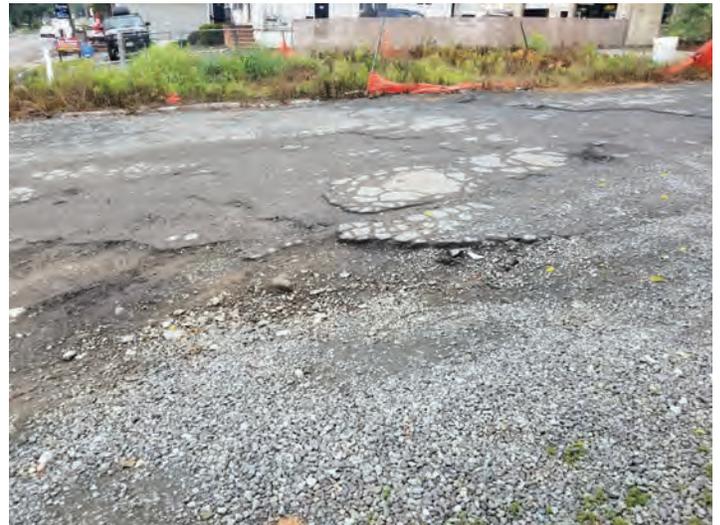
Figure 5: Driveway deterioration.

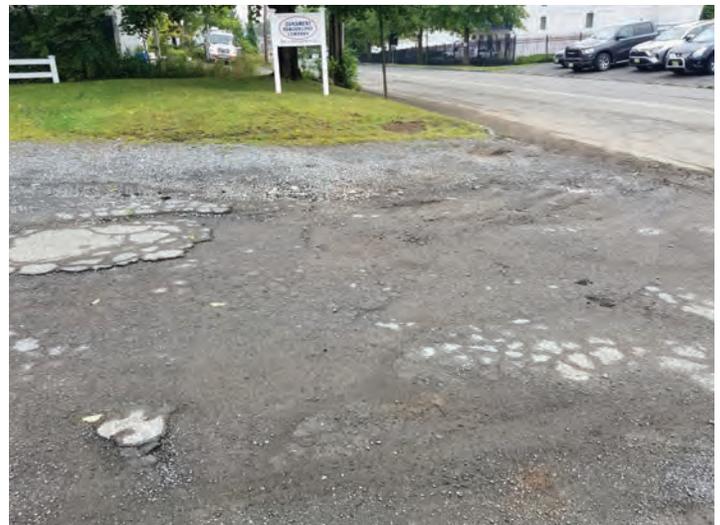
Figure 7: Driveway deterioration.

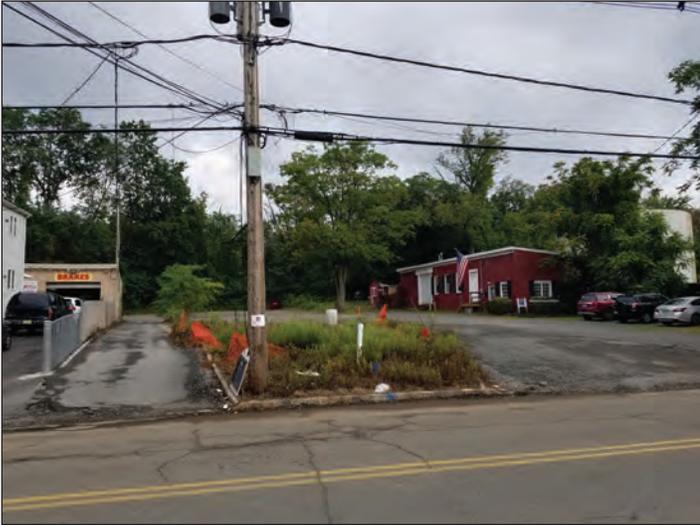
Figure 2: Vegetation and deteriorated driveway on Lots 6 and 7, from across River Road.

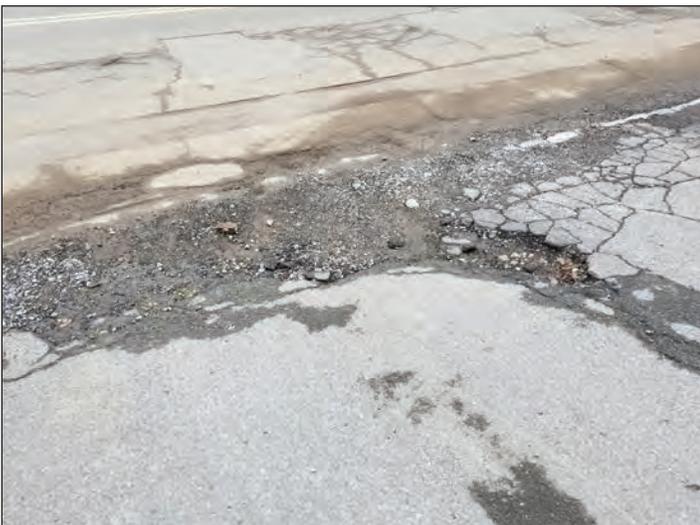
Figure 4: Damaged driveway apron on Lot 6.

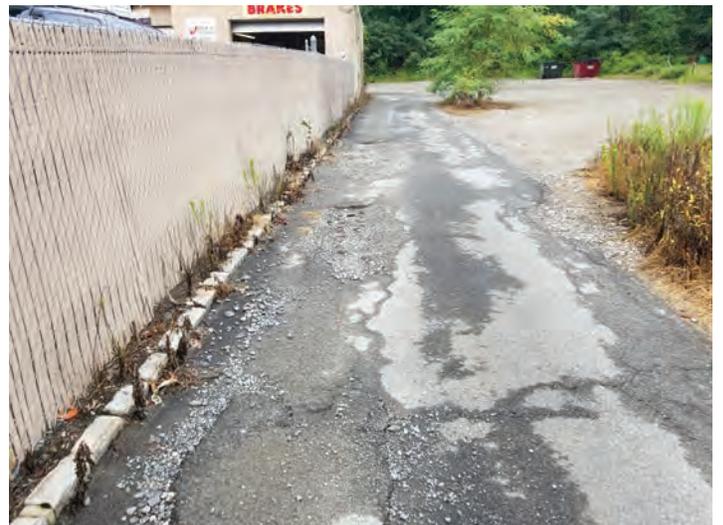
Figure 5: Damaged driveway on Lot 6

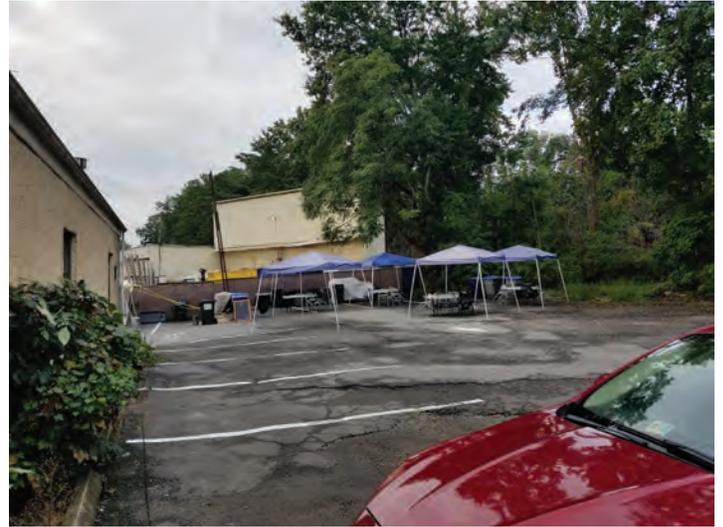
Figure 8: Outdoor dining area in rear of Lots 4 and 6. Damaged parking area pavement.

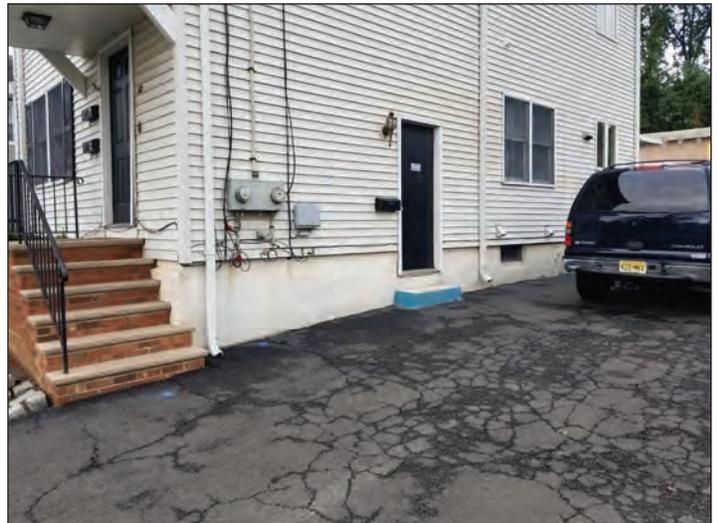
Figure 4: Side building entrance. Roof leader downspouts opening onto driveway near building wall and stairs.

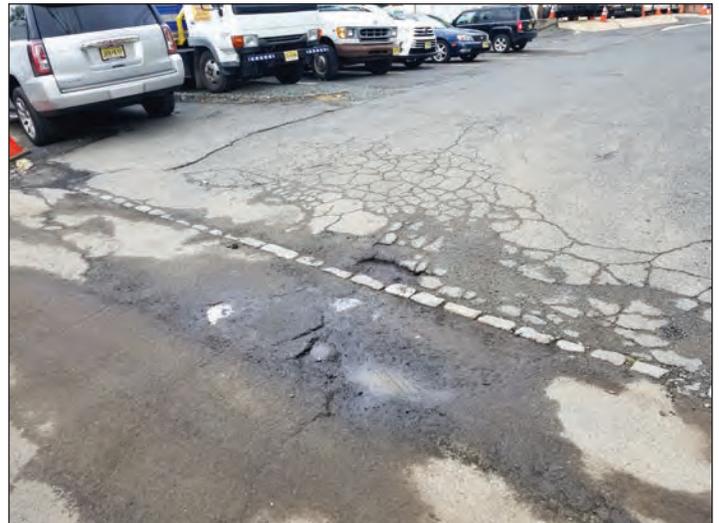
Figure 4: Damage to driveway entrance and cartway.

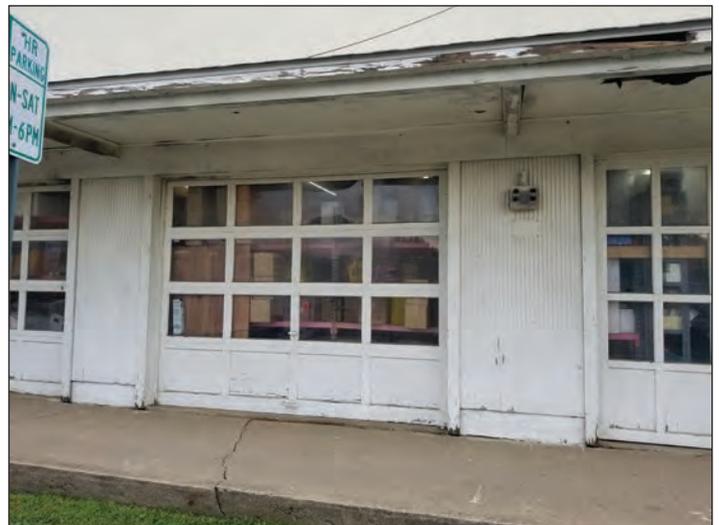
Figure 12: Rotting wood on eaves. Cracked walkway.

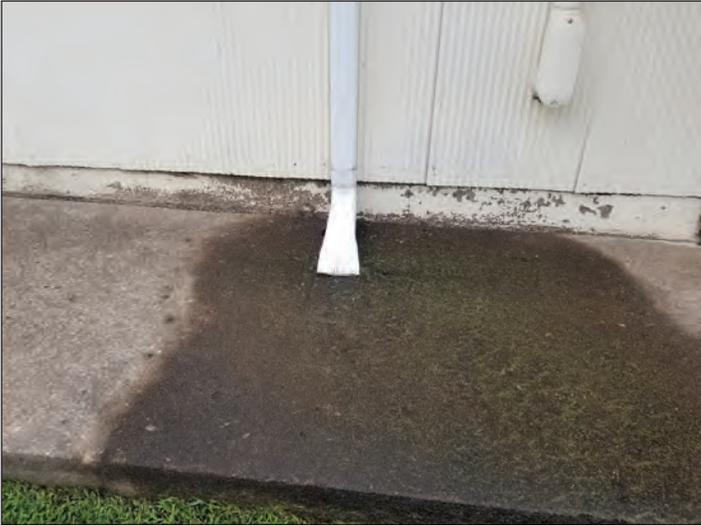
Figure 13: Damaged downspout shoe, with water soaking walkway below. Visible water damage to building wall.

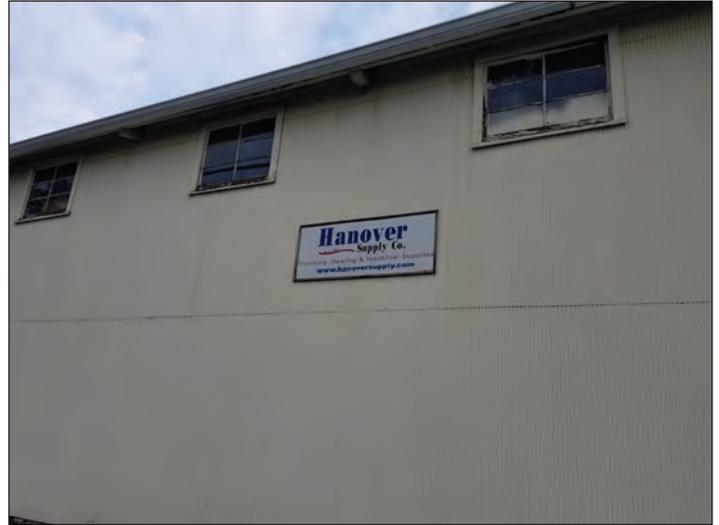
Figure 14: Faded paint and possible rotting of second story window frames.

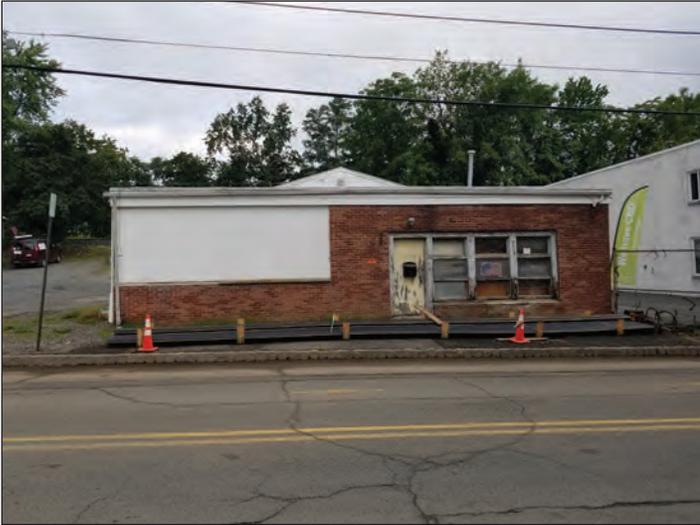
Figure 1: Front of building. Rotting wooden door, frames. Water stained brick. Outdoor storage in front yard.

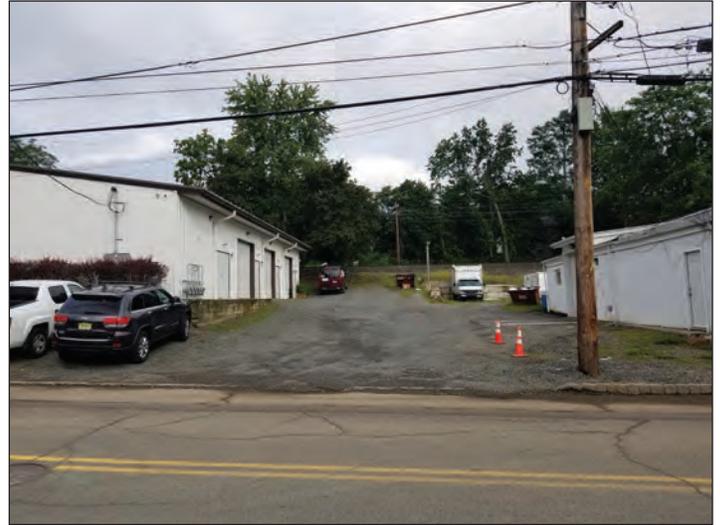
Figure 2: Gravel and deteriorated pavement driveway (unnamed public right-of-way) between Blocks 135 and 136.

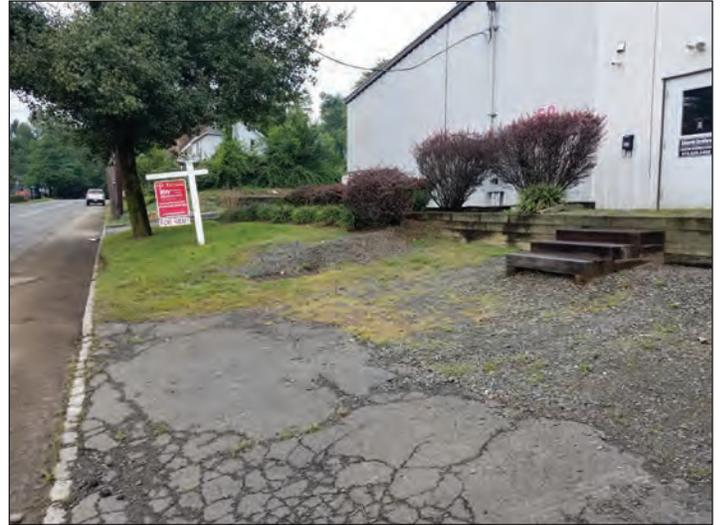
Figure 2: Steps to front entrance from deteriorated, inclining parking area.

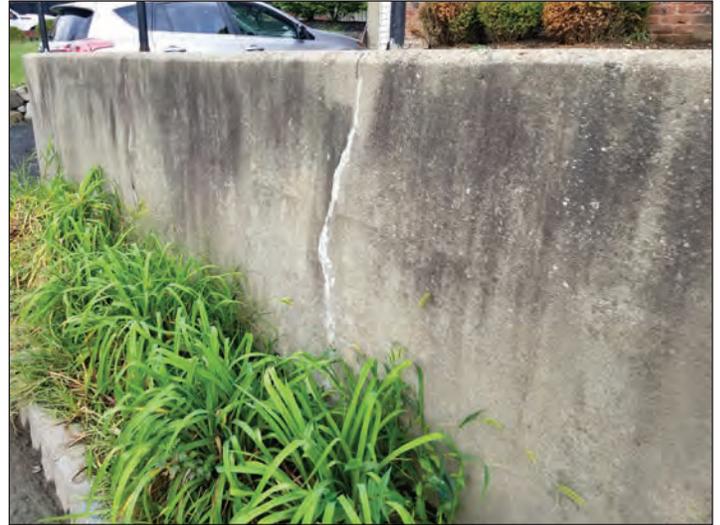
Figure 2: Patched crack in retaining wall along River Road.

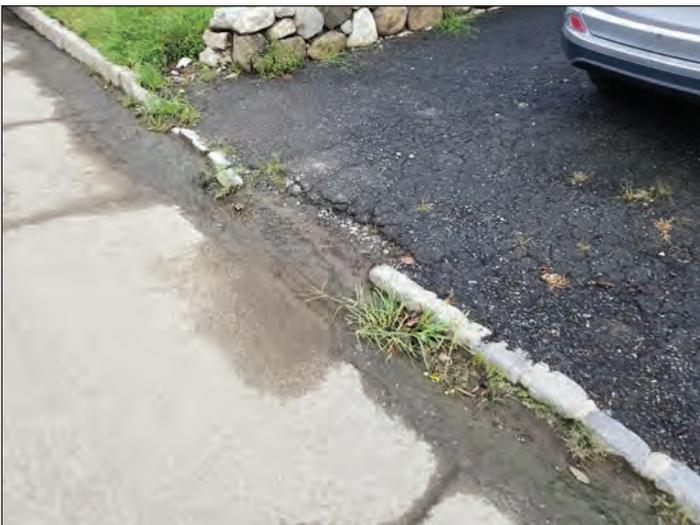
Figure 3: Damaged driveway apron and missing curb blocks.

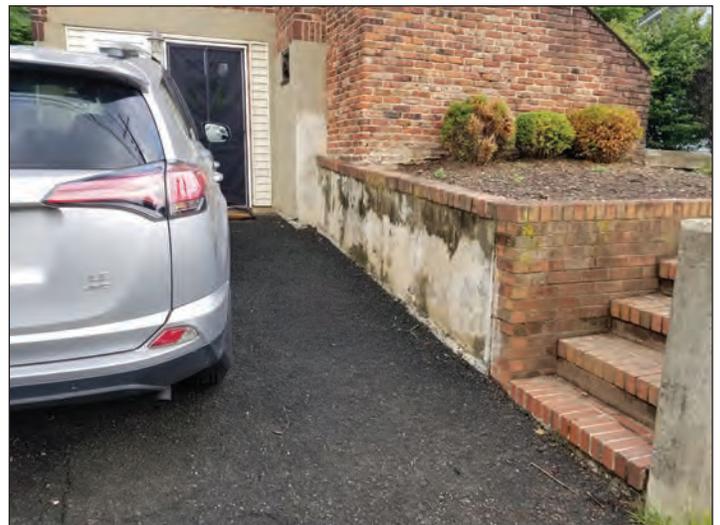
Figure 4: Water staining on retaining wall adjacent to parking lot.

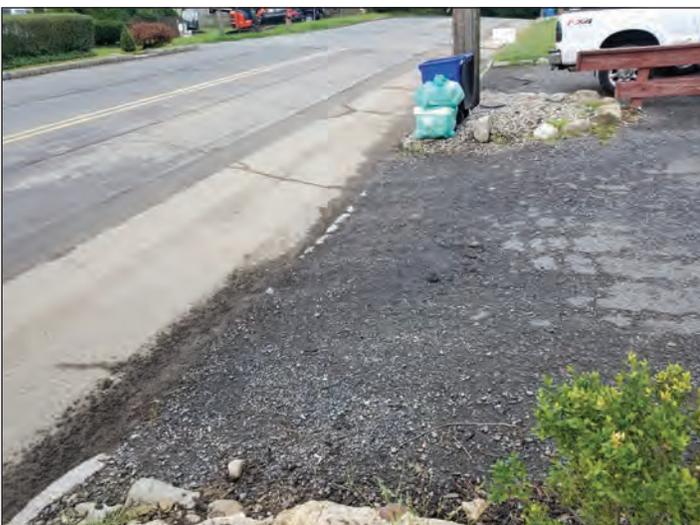
Figure 5: Deteriorated driveway and driveway apron leading to rear parking area.

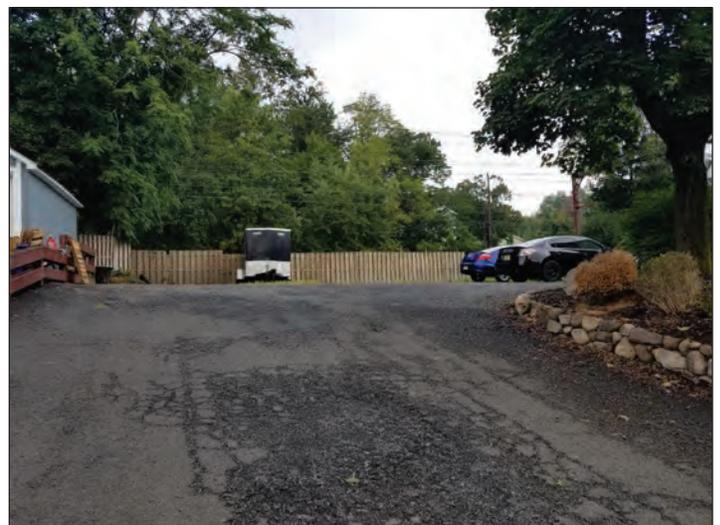
Figure 6: Rear parking area as viewed from driveway apron. Additional deteriorated pavement visible.

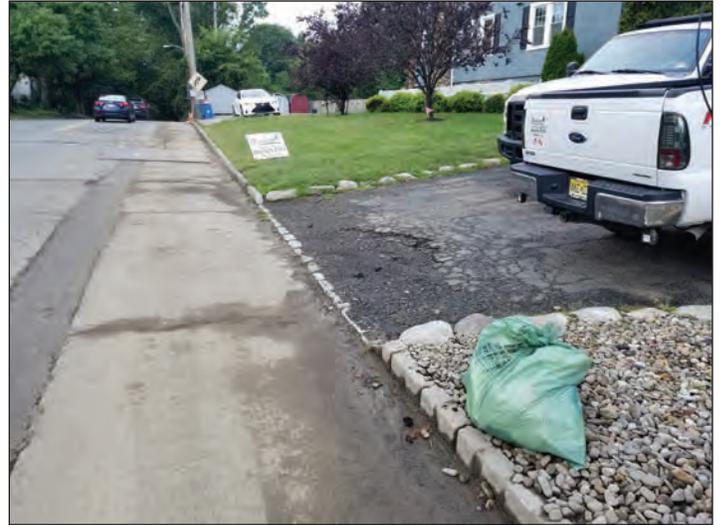
Figure 2: Deteriorated driveway.

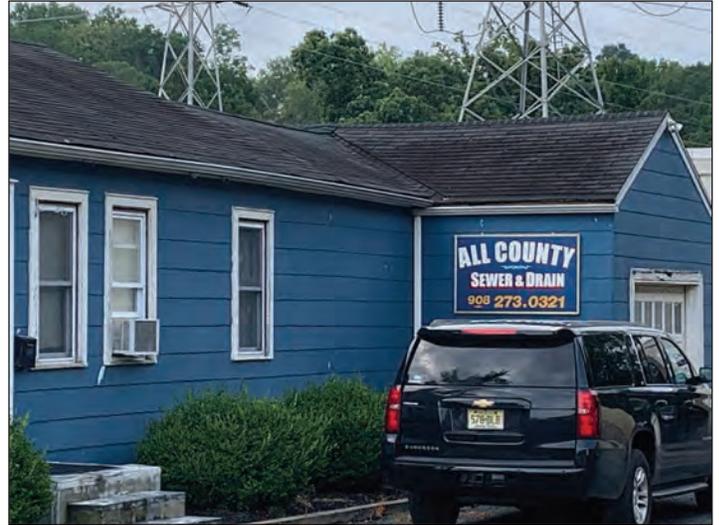
Figure 2: Close-up of building. Mild paint and siding wear, possibly indicative of rotting wood.

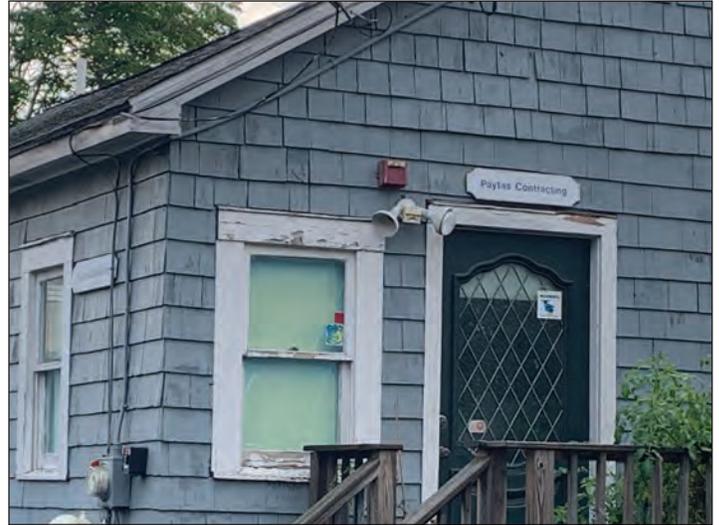
- The wood siding materials and window treatments on the office building are rotting and wearing away. This can affect insulation and permit intrusion of water and moisture into the structural parts of the building or the work spaces therein.
- Windows also appear from the outside to be blocked or boarded up, which may be a fire safety hazard as well as an obstruction of access to natural air and light.
- The combination of the above conditions make the building unsuitable for occupancy. (Criterion "a")

Figure 2: Rotting door and window frames. Moss accumulating on roof. Visible wear and shifting of siding materials.

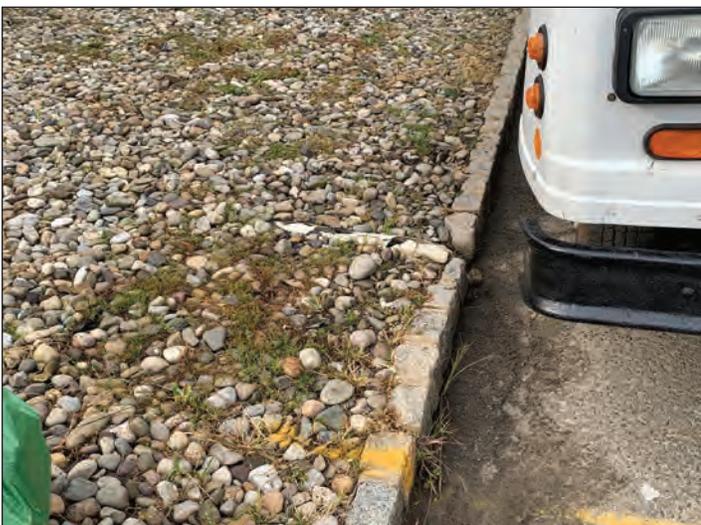
Figure 3: Damaged stormwater pipe opening into cartway. Visible sediment accumulation along curb.

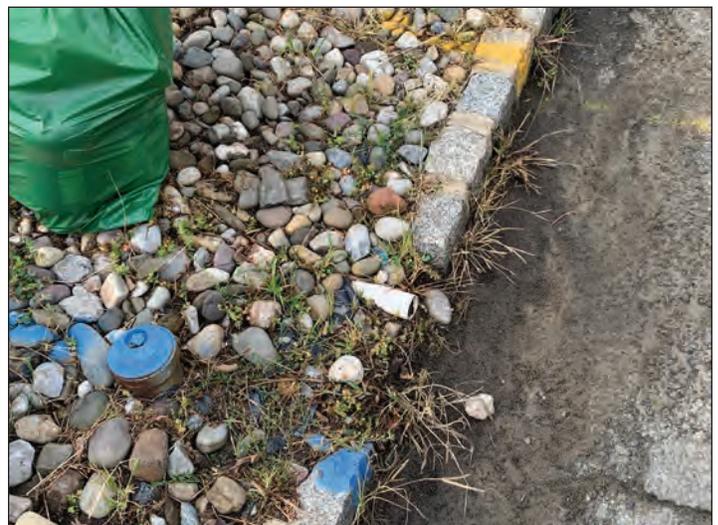
Figure 4: Damaged stormwater pipe opening into cartway. Visible sediment accumulation along curb.

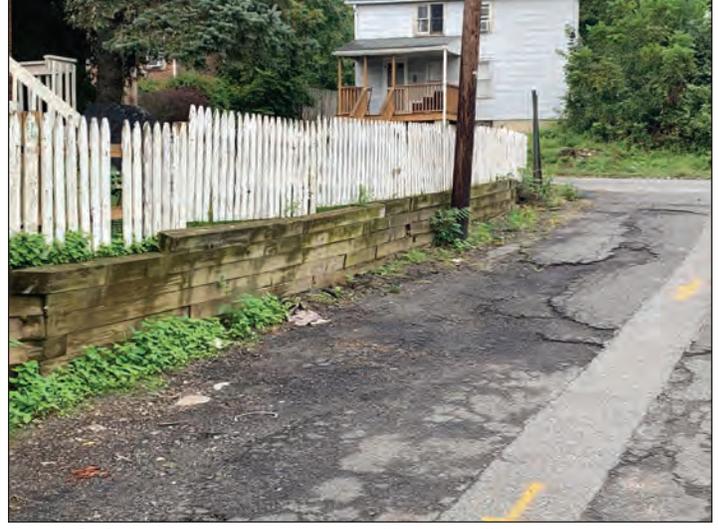
Figure 3: Deteriorated conditions on St. James Street, warped fence and retaining structures.

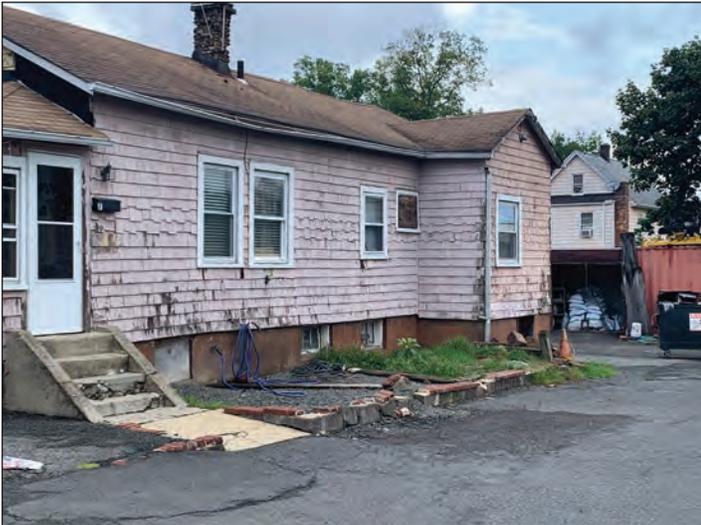
The one-story office is dilapidated, as can be seen in Figures 1 through 5 on the following pages. These signs include rotting siding, roof, and window materials; crumbling walls and foundations; and window openings or other wall penetrations that are uncovered or are covered with plywood. (Criterion "a" and "d", dilapidated building)

Figure 1: Office building with rotting siding, deteriorated chimney, collapsing gutters, plywood-covered windows, and unsafe stairs.

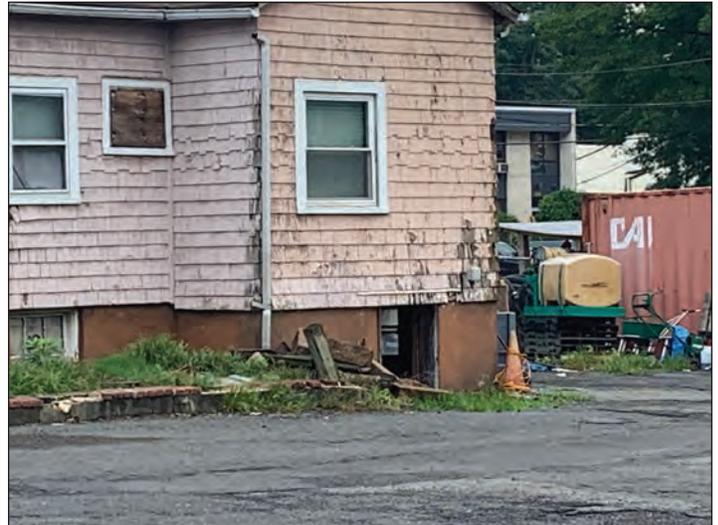
Figure 2: Open wall penetration, closer view of rotting siding, damaged curbs, downspout disconnected from gutter.

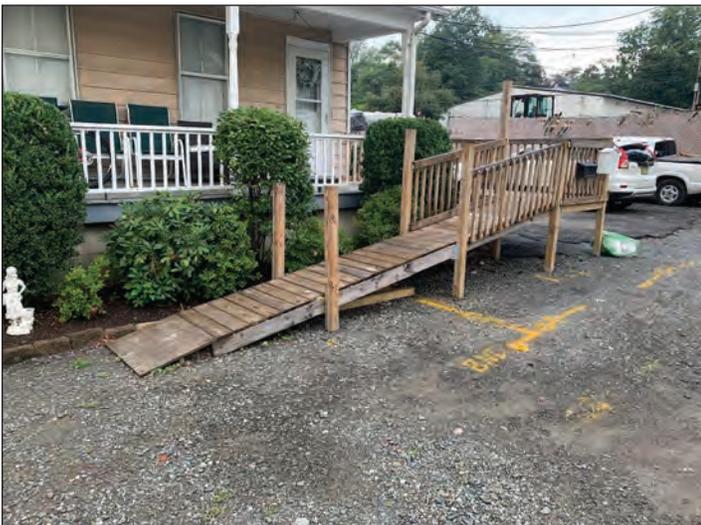
Figure 3: Unsafe wheelchair ramp with missing and failing rails.

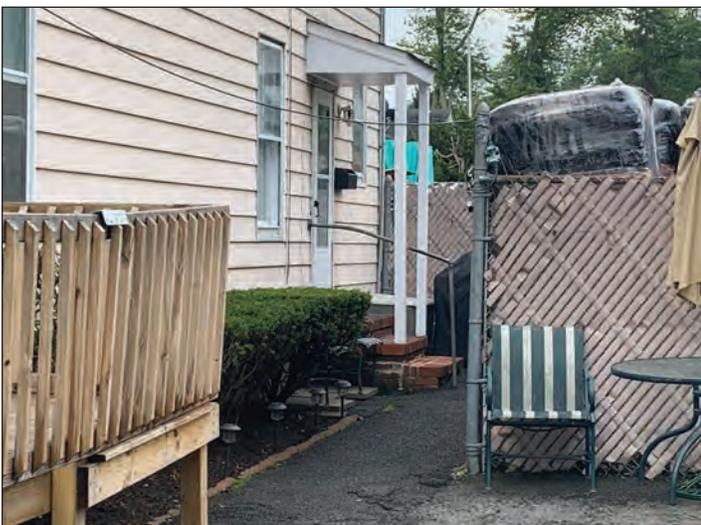
Figure 5: Steps to side building entrance (middle ground) and close up of failing ramp rails in lower left corner of image.

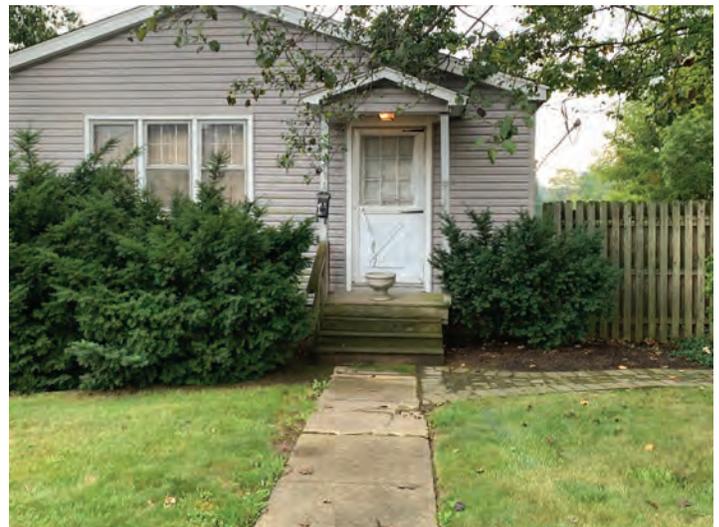
Figure 1: River Road building entrance. Incomplete railing system.

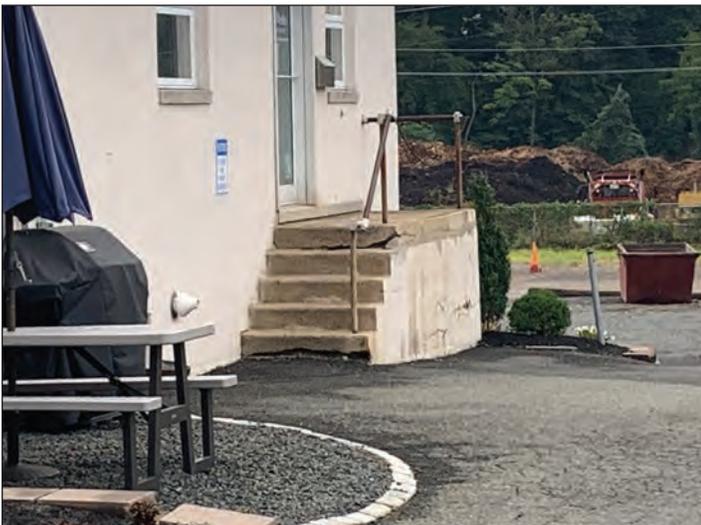
Figure 3: Deteriorated side door stairs, with missing safety rail.

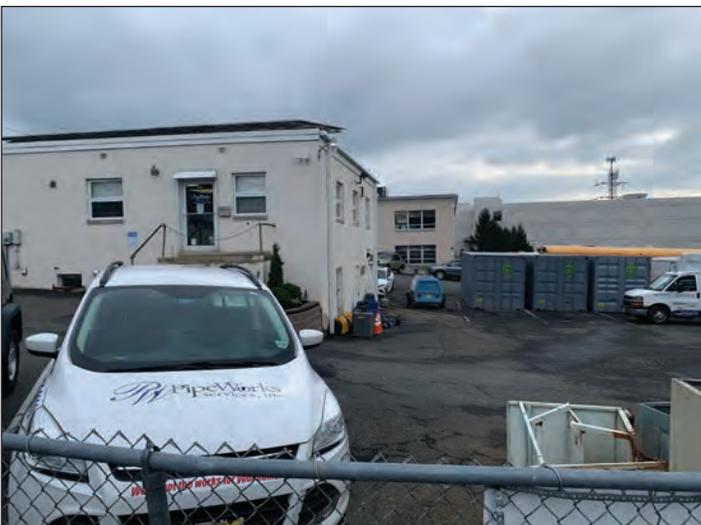
Figure 5: Southeast corner of building. Visible evidence of severe deterioration of side stair landing.

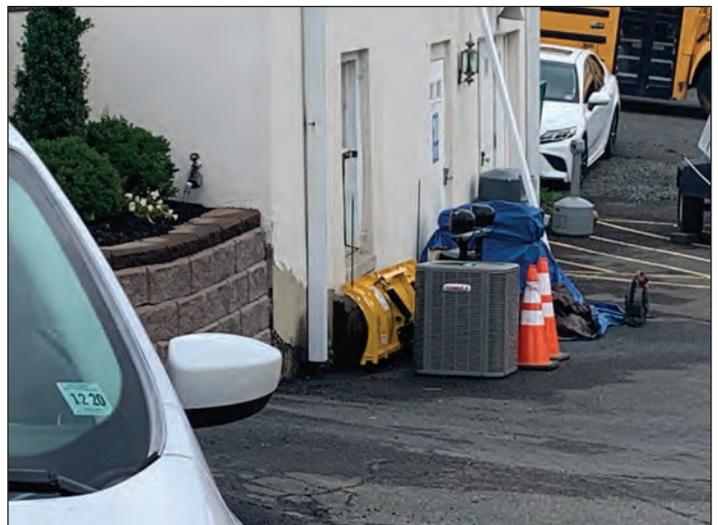
Figure 6: Downspout releasing onto pavement near building edge. Visibly deteriorated wall from water exposure.

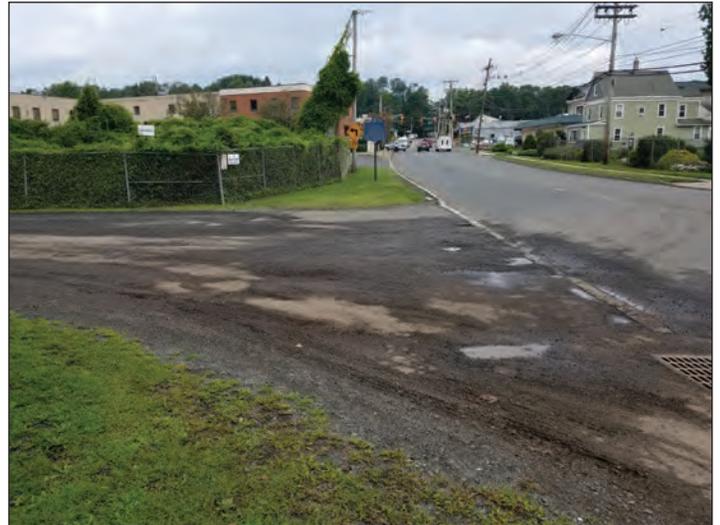
Figure 2: Driveway apron comprised of gravel and deteriorated pavement. Potholes forming.

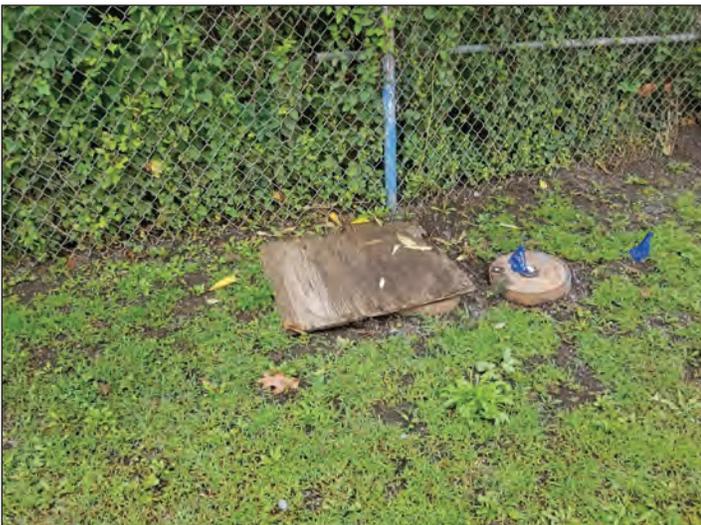
Figure 3: Exposed pipes covered with plywood.
