Preliminary Investigation for Determination of an Area in Need of Redevelopment and Rehabilitation

Block 134, Lots 1-7 & 26-28; Block 135, Lots 1-8 & 13-14; Blocks 136-140 (All Lots)

Prepared For:
Borough of Chatham
Morris County, New Jersey
July 2021

Prepared By:
DMR Architects

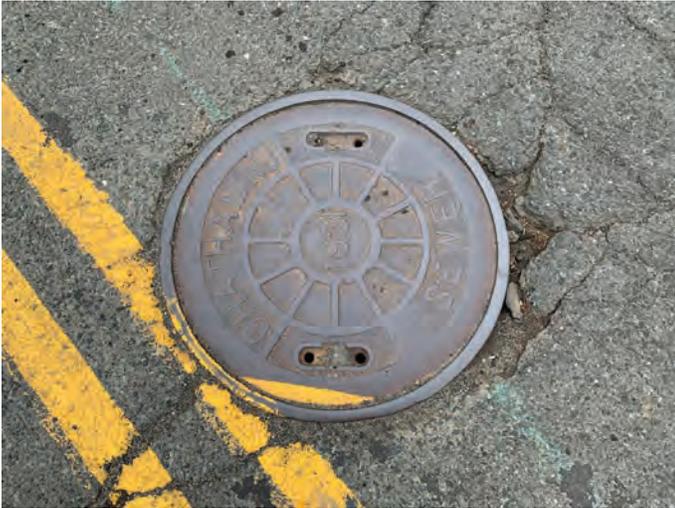
Image 1 - Manhole #1: Manhole cover with dated 1931 located on River Road.

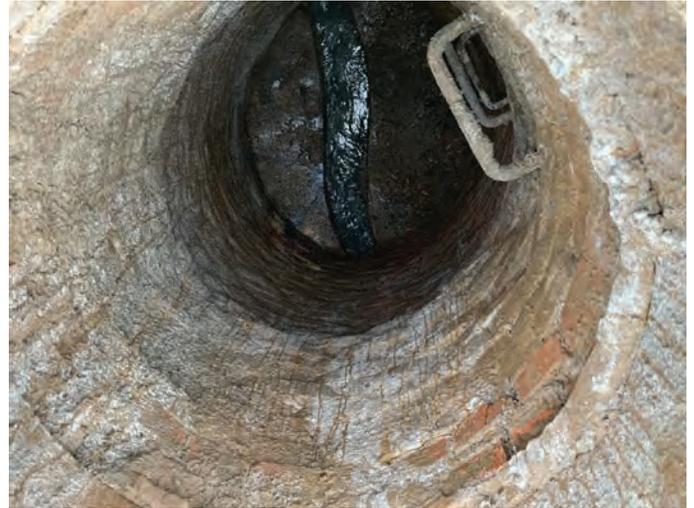
Image 2 - Manhole #1: Brick arch sewer line located on River Road.

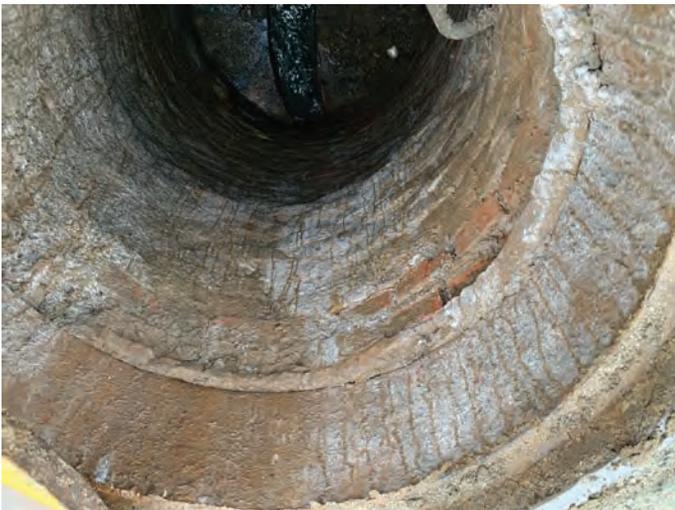
Image 3 - Manhole #1: Brick arch line located on River Road.

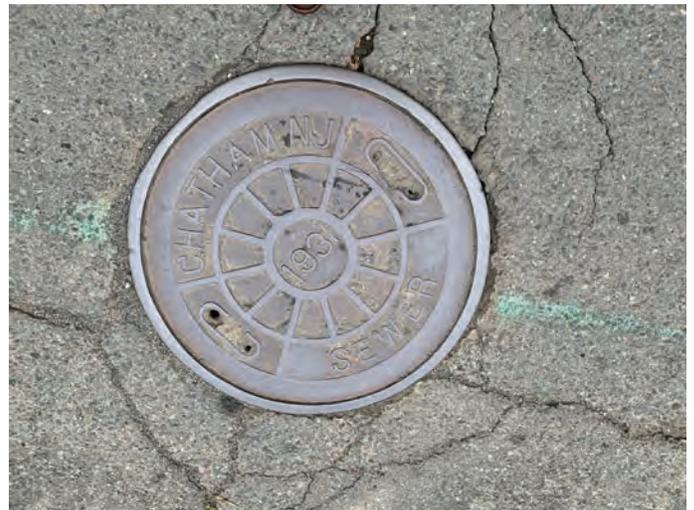
Image 4 - Manhole #2: Manhole cover with dated 1931 located on River Road.

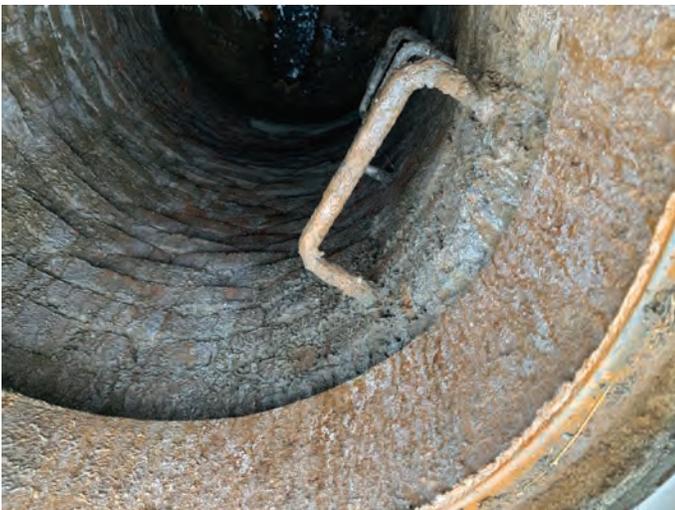
Image 5 - Manhole #2: Brick arch line located on River Road.

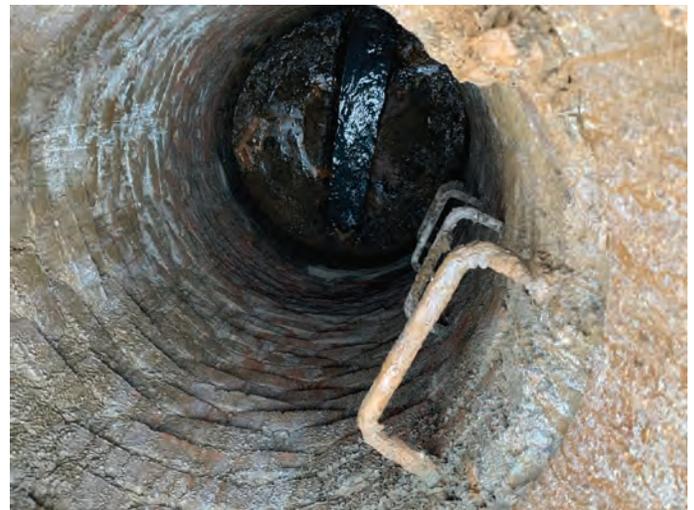
Image 6 - Manhole #2: Brick arch line located on River Road.

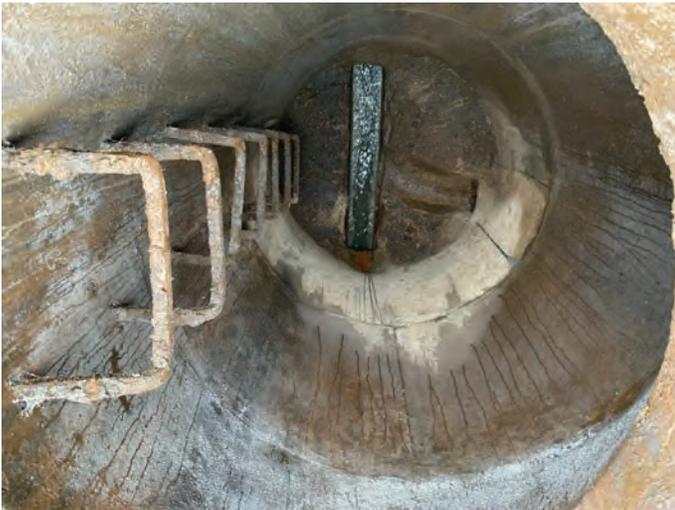
Image 7 - Manhole #3: Concrete sewer line located between two brick arch lines located on River Road.

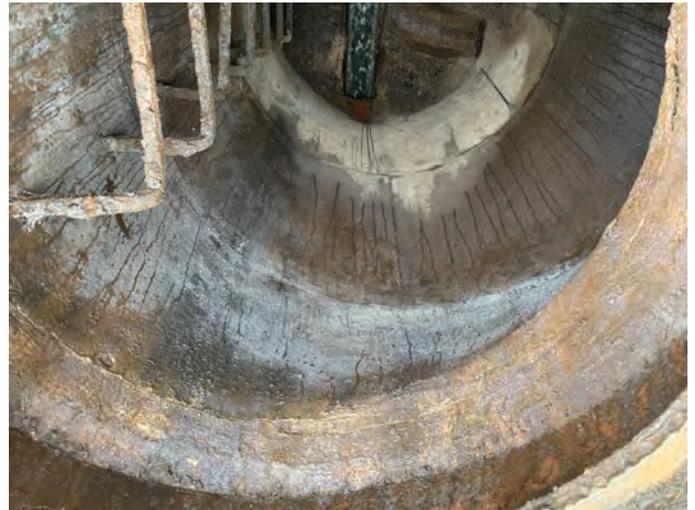
Image 8 - Manhole #3: Concrete sewer line located between two brick arch lines located on River Road.

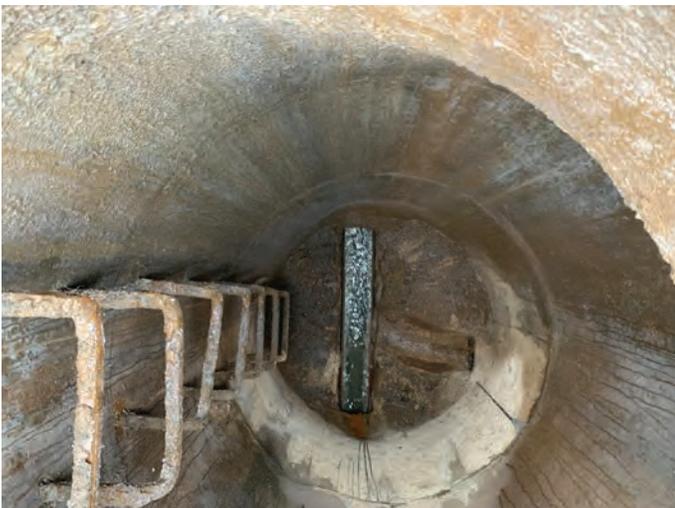
Image 9 - Manhole #3: Concrete sewer line located between two brick arch lines located on River Road.

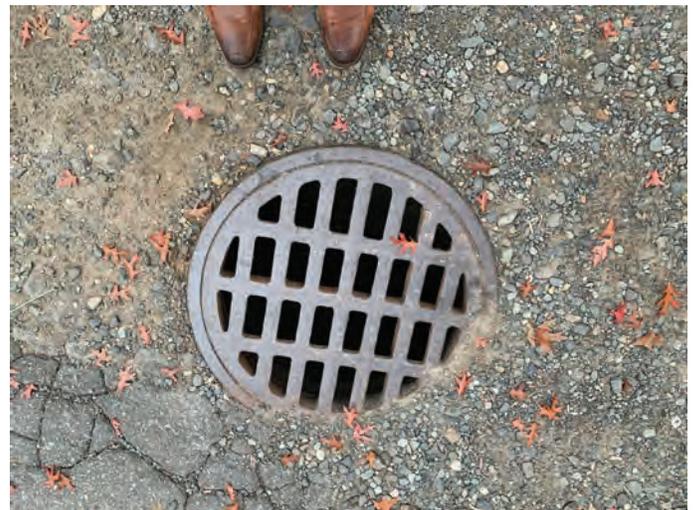
Image 10 - Storm-water: Storm-water cover located on Perrin Street.

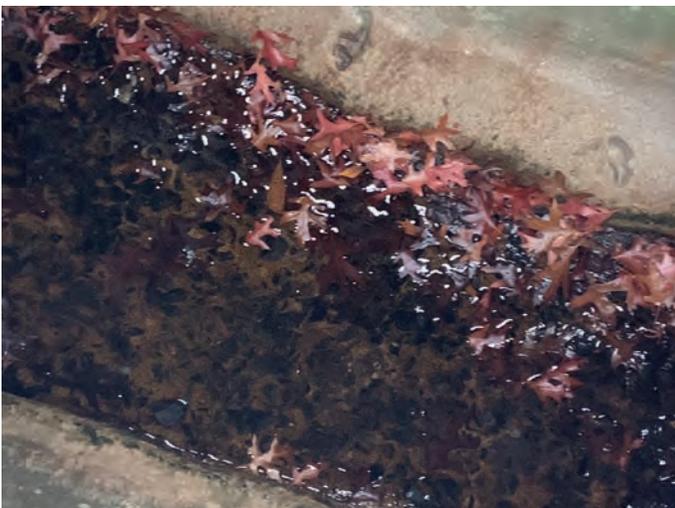
Image 11 - Storm-water: Debris located at the base of the storm-water line located on Perrin Street.

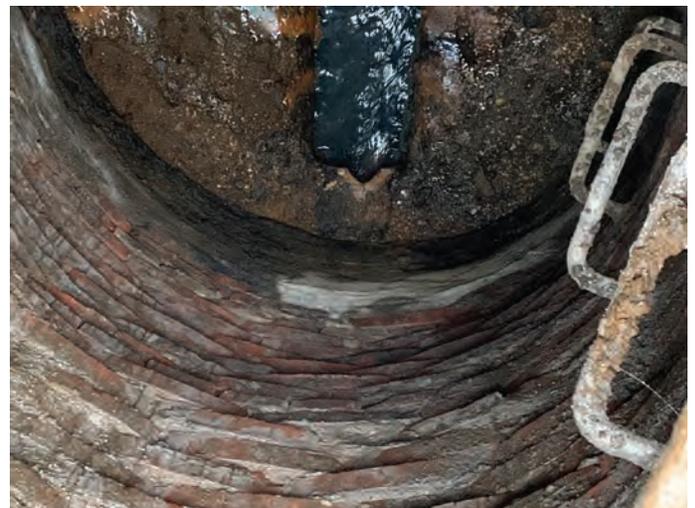
Image 12 - Manhole #4: Brick arch sewer line located on River Road.

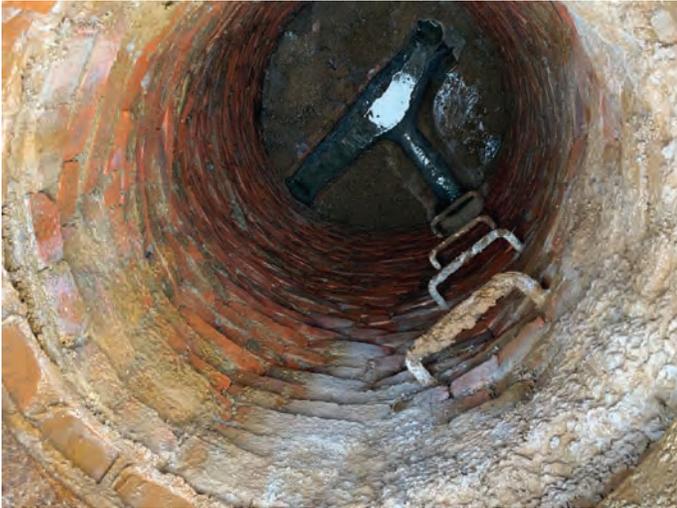
Image 13 - Manhole #4: Brick arch sewer line located on River Road.

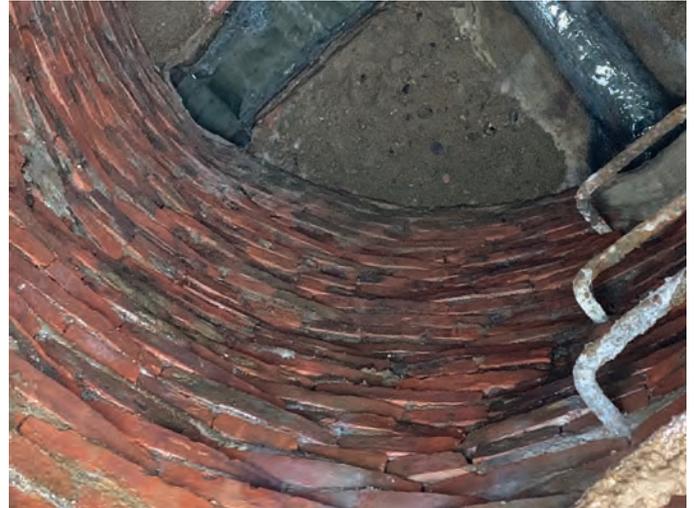
Image 14 - Manhole #4: Brick arch line located on River Road.

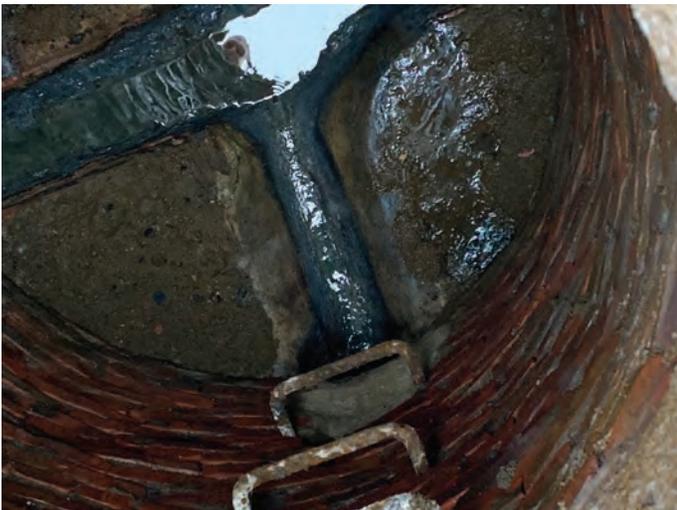
Image 15 - Manhole #4: Manhole cover with dated 1931 located on River Road.

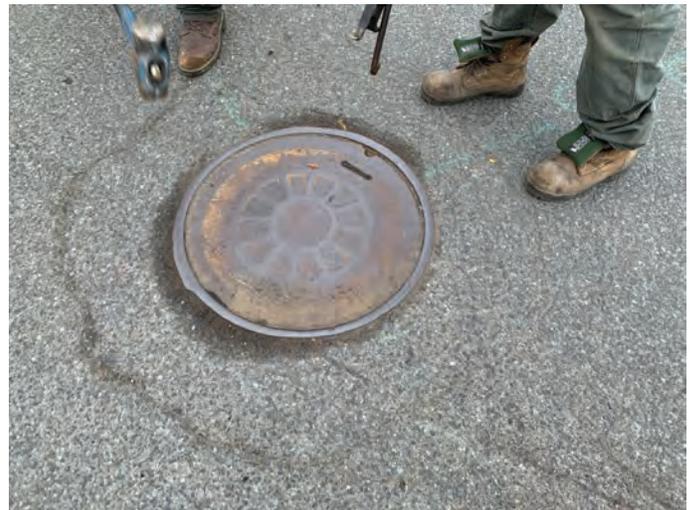
Image 16 - Manole # 5:: Sewer cover located at the intersection of River Road and Watchung Avenue.

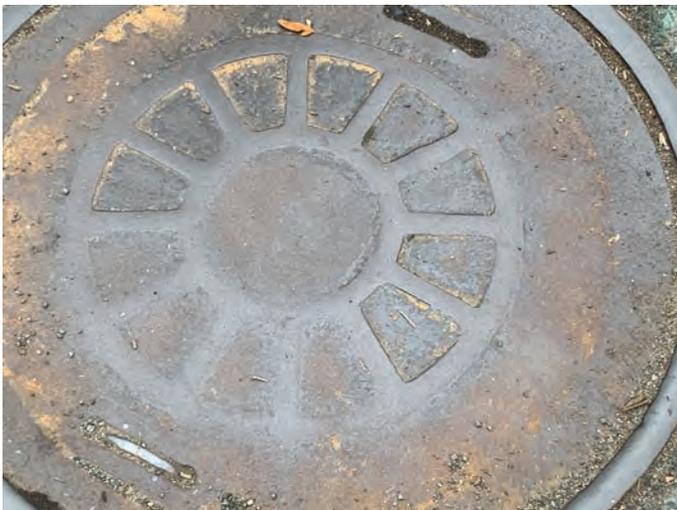
Image 17 - Manole # 5:: Sewer cover located at the intersection of River Road and Watchung Avenue with no visible date due to it's condition.

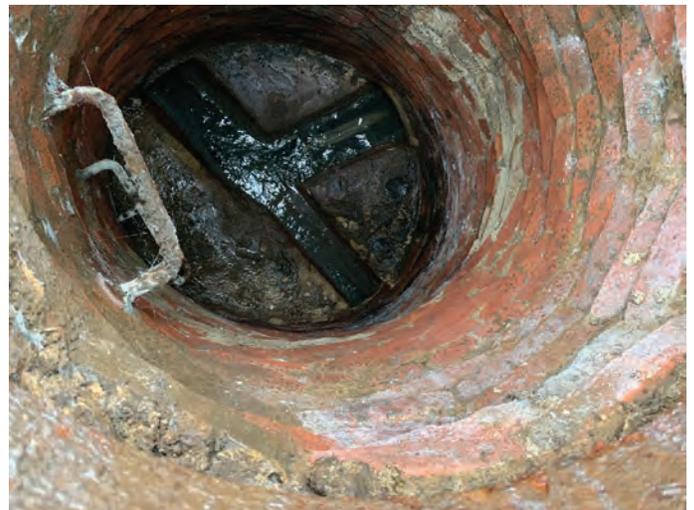
Image 18 - Manole # 5:: Brick arch line located at the intersection of River Road and Watchung Avenue.

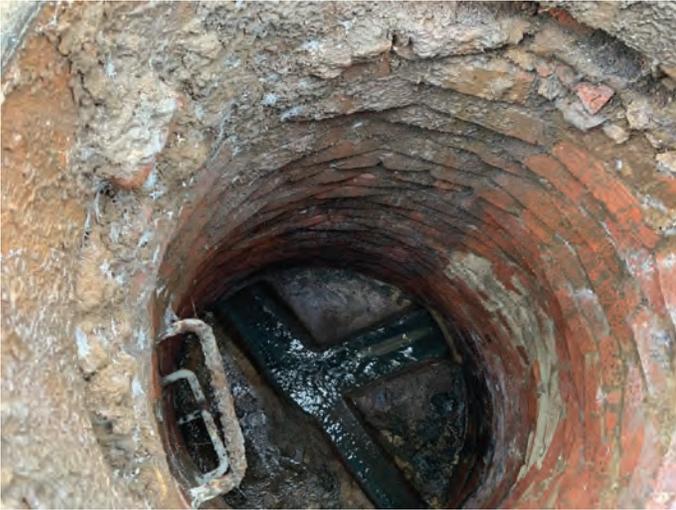
Image 19 - Manole # 5: Brick arch line located at the intersection of River Road and Watchung Avenue.

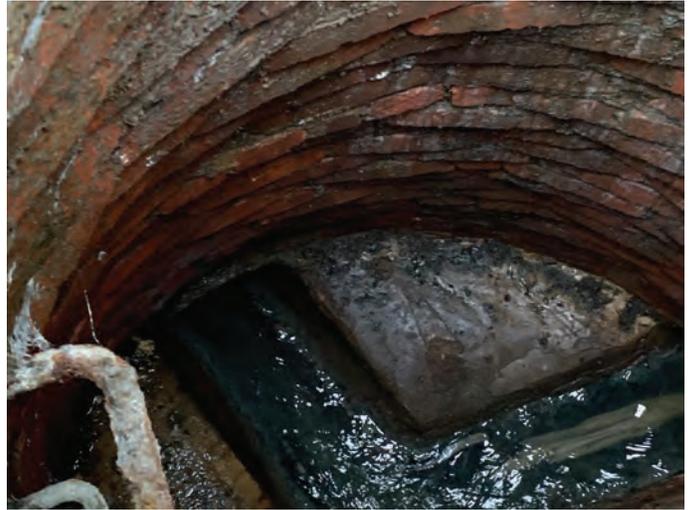
Image 20- Manole # 5: Brick arch line located at the intersection of River Road and Watchung Avenue.

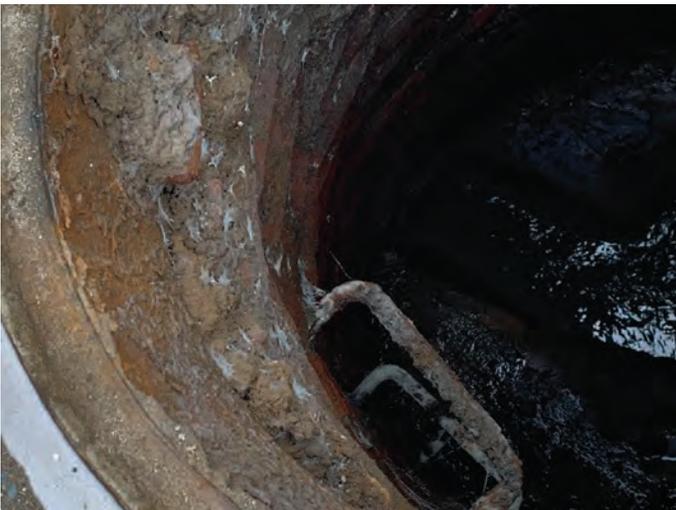
Image 21 - Manole # 5: Brick arch line located at the intersection of River Road and Watchung Avenue.

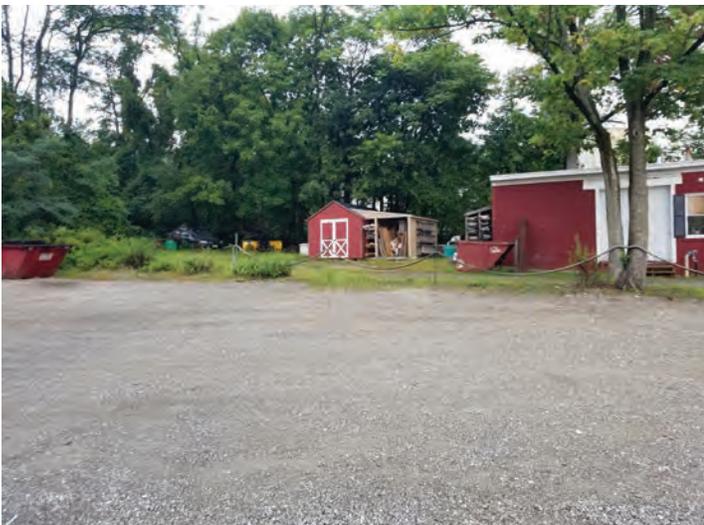
Figure 6: Outdoor storage and accessory building in rear of lot.

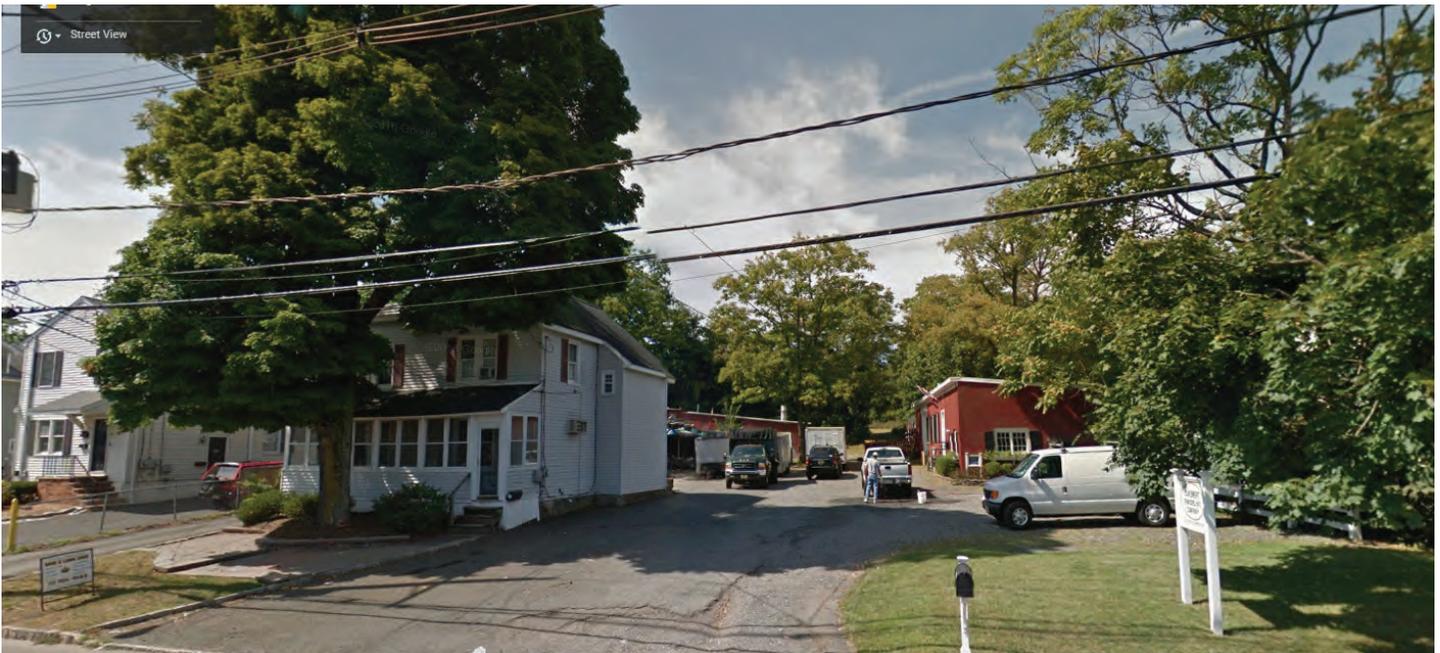
- Figure 1 shows a dwelling on Lot 7 and a red building on Lot 6 in 2013. The driveway to the left of the dwelling is the driveway portion of Lot 6. Since the buildings on Lots 6 and 7 were been demolished, there have been no improvements to the appearance of the lots or to the access points and surfaces. Therefore, it appears that the layout issues plaguing the site are caused by obsolete layouts from before buildings on Lots 6 and 7 were demolished. (Criterion "d" per Section IV.2)

Figure 1: Google Streetview Image from September of 2013.

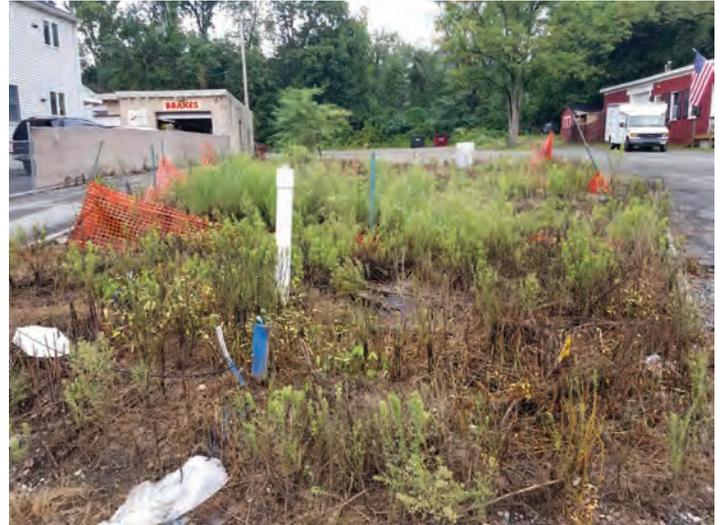
Figure 3: Vegetation in front yard of Lot 7

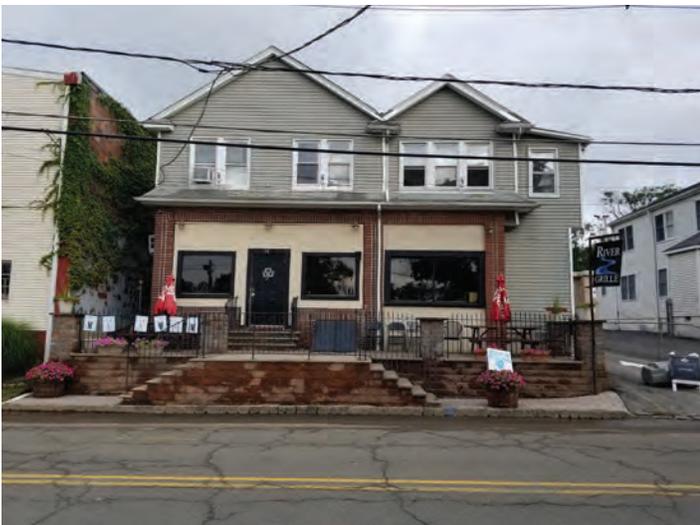
Figure 6: Commercial building on Lot 4.

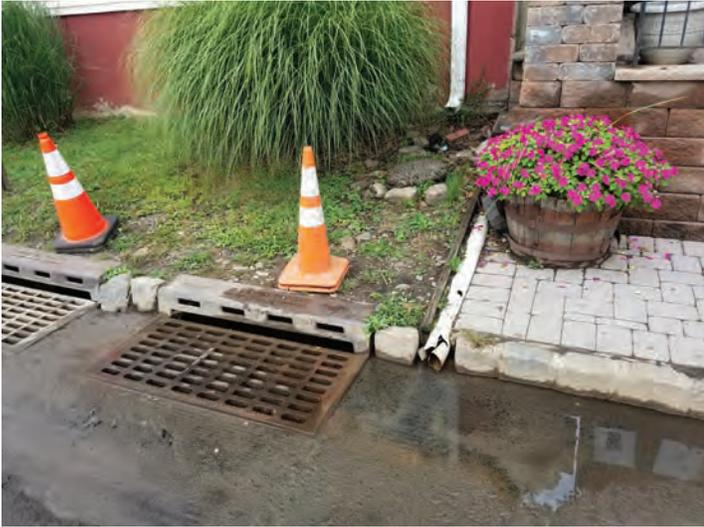
- Figure 7 also shows a puddle accumulating in the River Road right-of-way in front of Lot 4. The excessive amount of stormwater collecting in the street suggests that the site has an excess of impervious coverage that is not adequately addressed with on-site drainage systems. Excessive water in the right-of-way can accelerate damage to the road pavement on a street already experiencing heavy use from industrial activities. Damaged roads increase the likelihood of car accidents and generally make roads less usable. (Criterion "d" per Section IV.5)

Figure 7: Stormwater collecting near drain in River Road cartway.

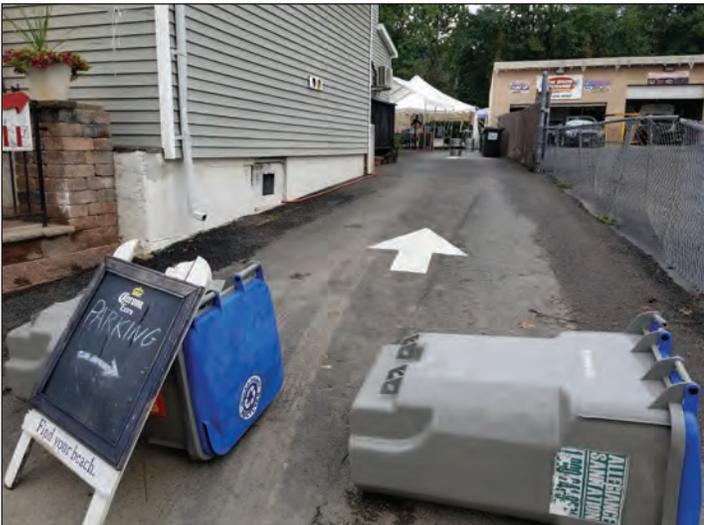
Figure 9: Driveway to rear parking area blocked to protect outdoor dining area.

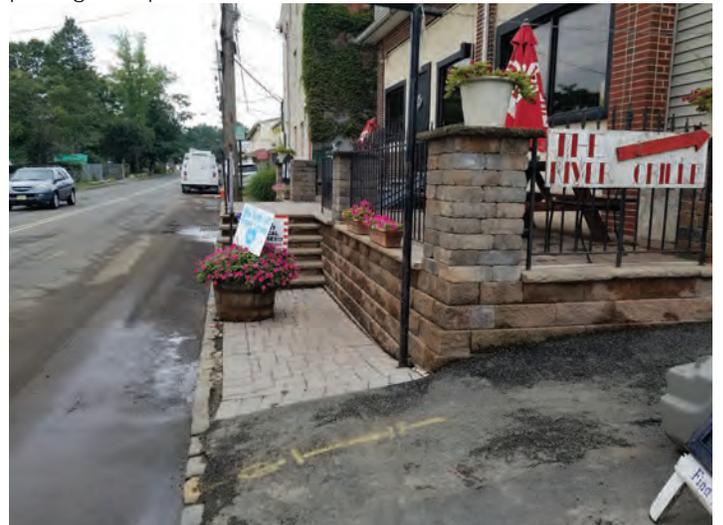
Figure 10: Steps to dining patio and restaurant entrance. No ADA accommodation.

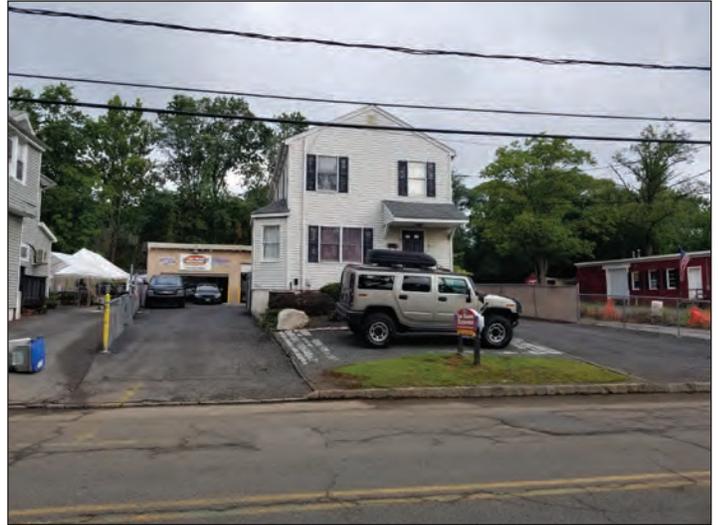
Figure 2: Dwelling as viewed from River Road. Auto-repair garage in back. Car parked on pavers in front yard.

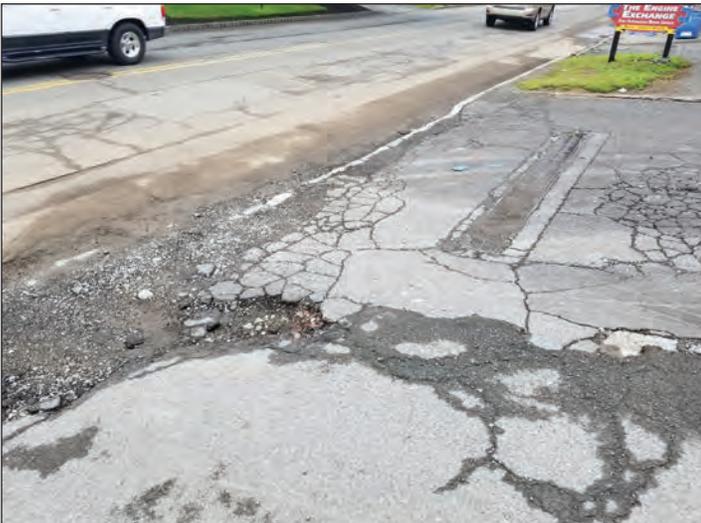
- The dwelling appears to be in good condition. DMR could not get a thorough view of the automobile service building from the River Road right of way, but it is in at least fair condition. The paved surfaces on the lot are in better condition than those on neighboring properties, but cracks are forming near areas where stormwater is prone to accumulating.
- There are trench drains at the lower points of the driveways, to collect stormwater before it reaches the street; however, the drains are clogged with sediment, limiting the drainage capabilities of the drains. (Criterion "d" per Section IV.5)

Figure 3: Deteriorated driveway to rear service shop.

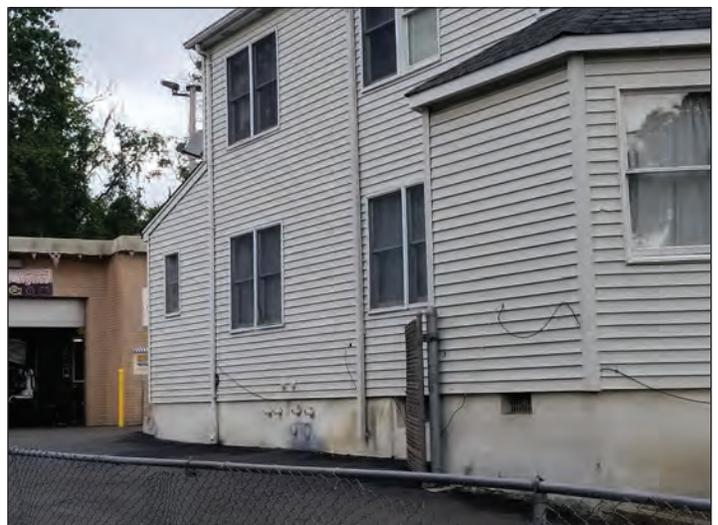
Figure 6: Side building wall. Roof leader downspouts opening onto driveway near building wall.

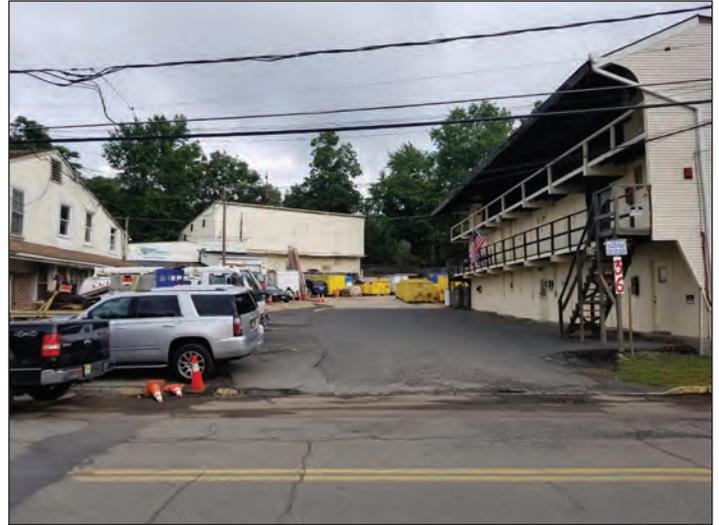
Figure 2: Driveway and parking to storage building and rear industrial building.

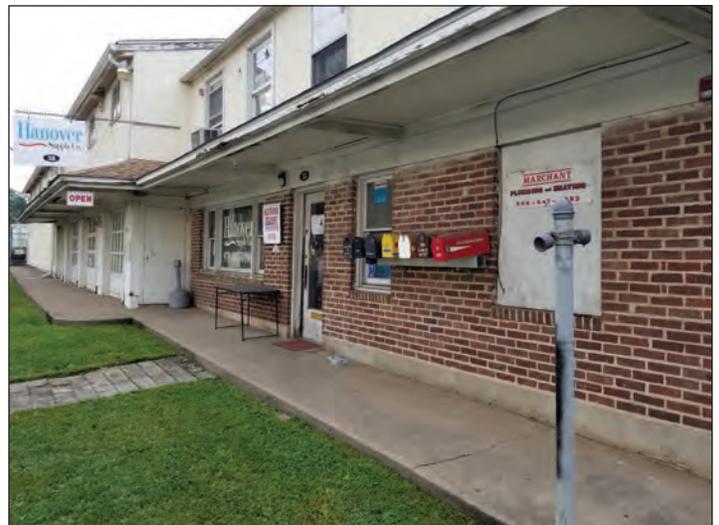
- The front-most building on the property, which contains a ground-floor retail use and second story offices, exhibits signs of deterioration. Most immediately visible is rotting wood on the overhanging eaves in front of the store, old wood siding, and wood window frames and treatments (Figures 6-14). Aluminum siding on other parts of the building are rotting and becoming detached from the building wall (Figure 15). (Criterion "d", dilapidation)
- The walkway around the building is deteriorating at varying rates, but is most severe where it is not protected by the overhanging roof (Figure 15). DMR also observed a marble slab being used to cover what appears to be a hole forming in the lawn adjacent to the walkway (Figure 9). DMR did not remove the slab to observe in more detail, but the hole may be indicative of foundation issues. (Criterion "d", dilapidation)

Figure 6: Entrance to Hanover Supply Co. store from River Road. Rotting wood visible on eaves. Multiple business mailboxes.

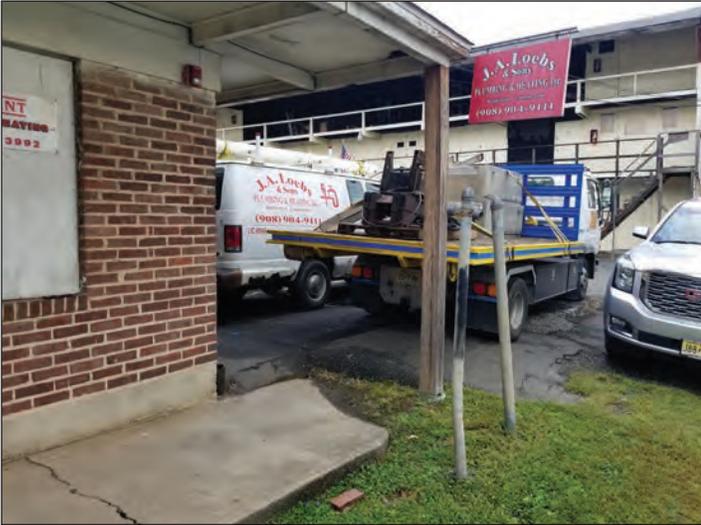
Figure 7: Cars parked adjacent to store. Lack of ADA accessibility due to abrupt grade change and overgrown pavement.

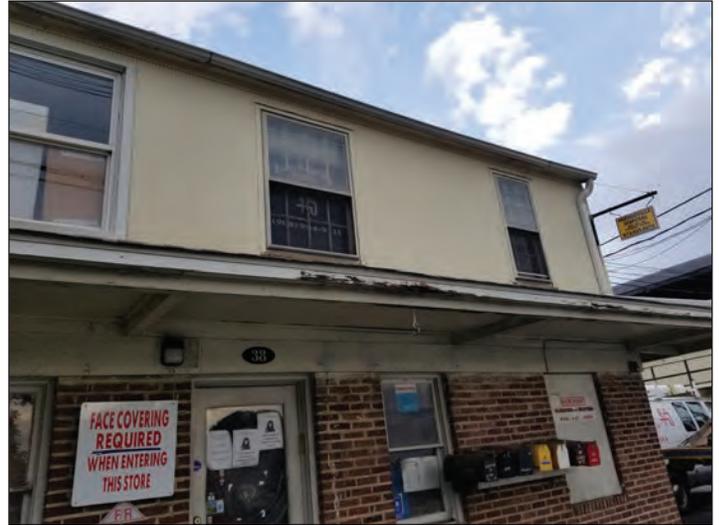
Figure 8: Rotting wood on eaves.

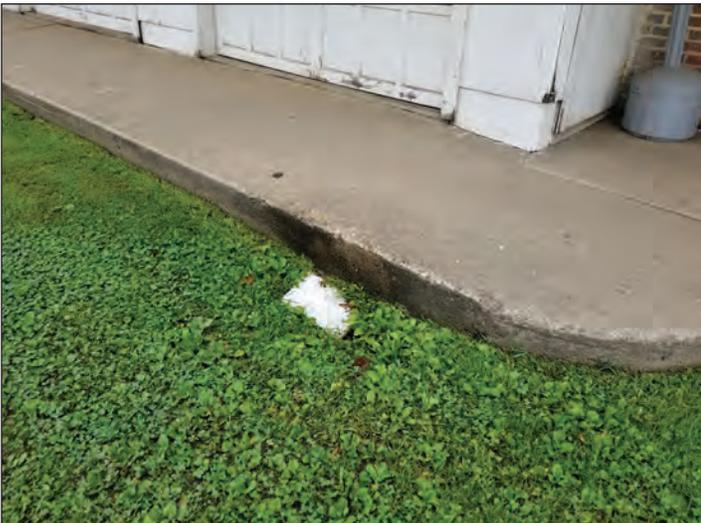
Figure 9: Marble block covering hole or ditch adjacent to walkway. Rotting siding visible on building.

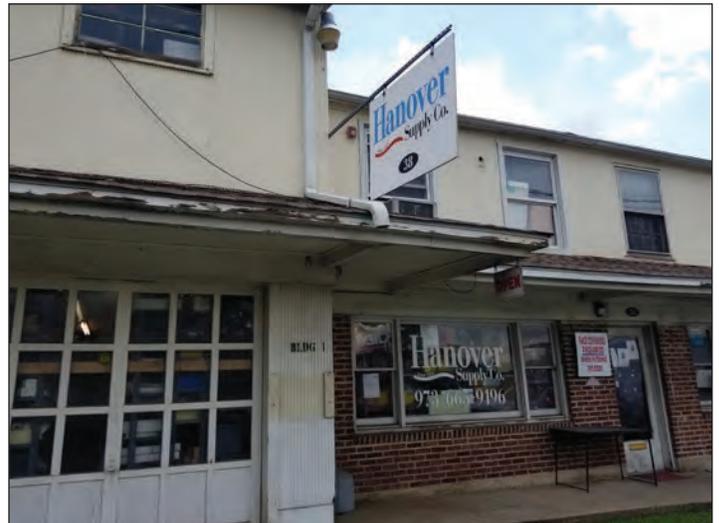
Figure 10: Rotting wood on eaves. Roof leader opening over walkway.

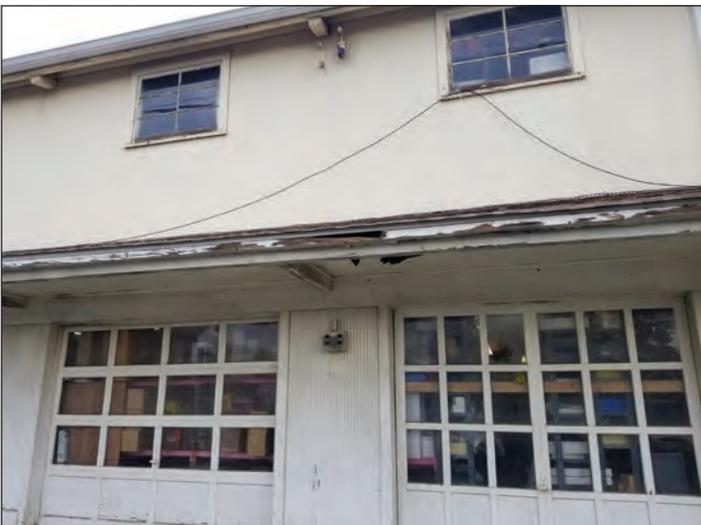
Figure 11: Rotting wood on eaves.

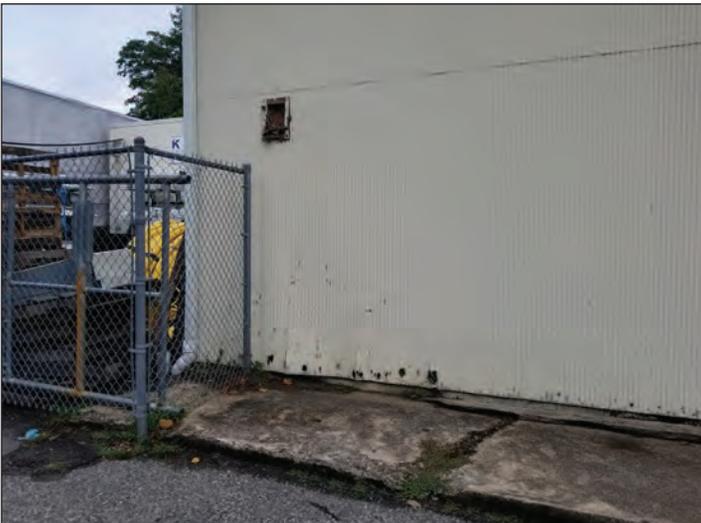
Figure 15: Rotting and warping of siding, deteriorated walkway.

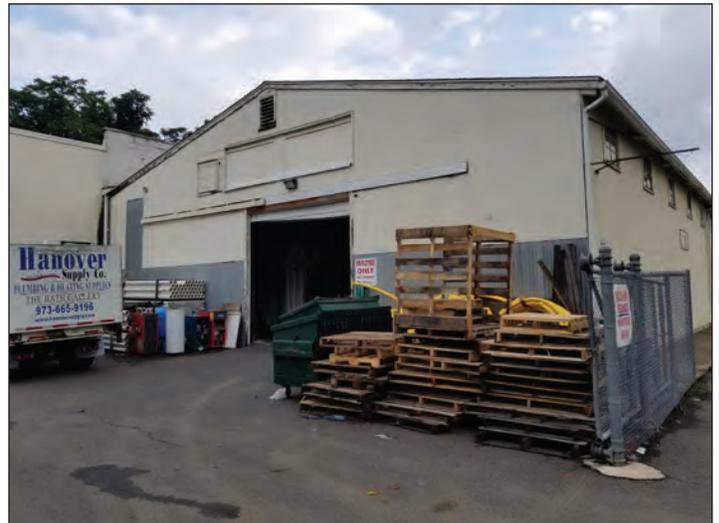
Figure 16: Outdoor storage of pallets, equipment, and other materials, and dumpster placed in truck maneuvering area.

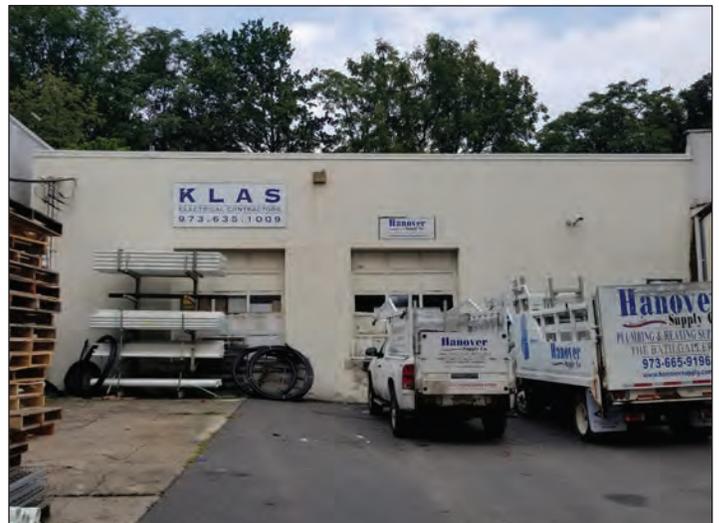
Figure 18: Close up of south loading/storage area. Visible grade change across area.

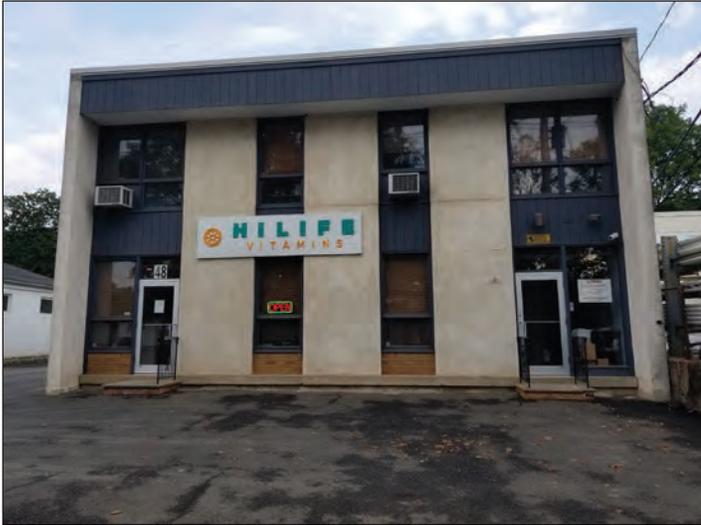
Figure 1: Office building viewed from River Road. Unit entrances are not ADA accessible.

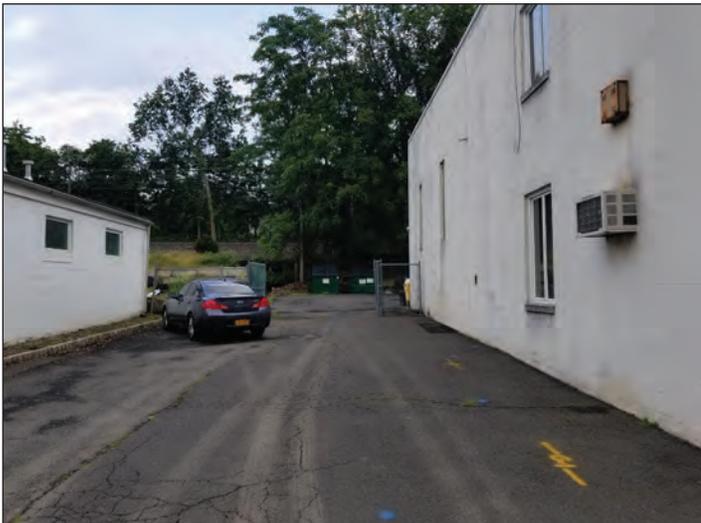
Figure 3: Close-up of un-striped parking area in driveway adjacent to building.

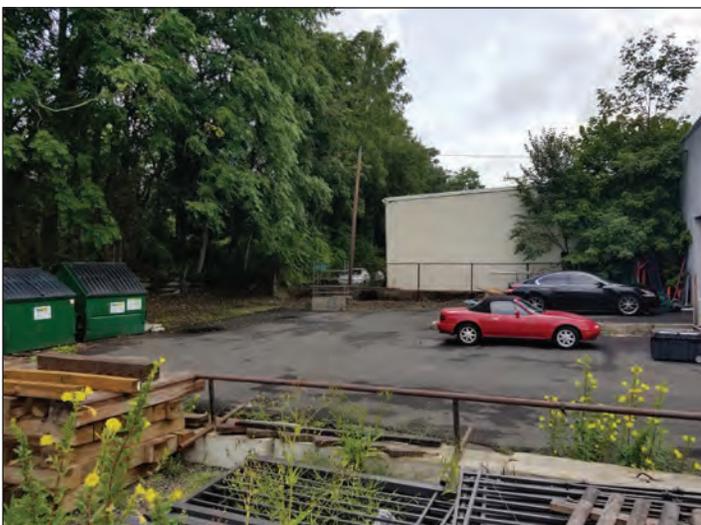
Figure 5: Rear parking and storage, and dumpster placement in rear yard. Visible grade change due to ramp to rear building wall.

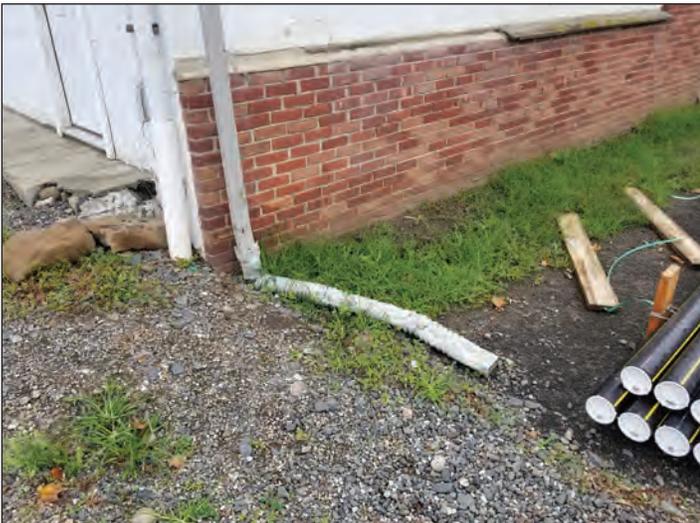
Figure 3: Downspout extender. Damaged walkway visible at building side. Missing masonry treatment on front facade.

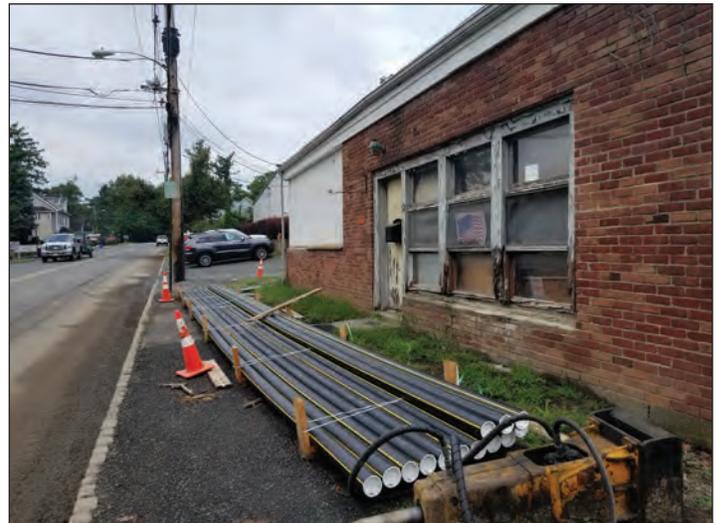
Figure 4: Materials and equipment stored on front yard.

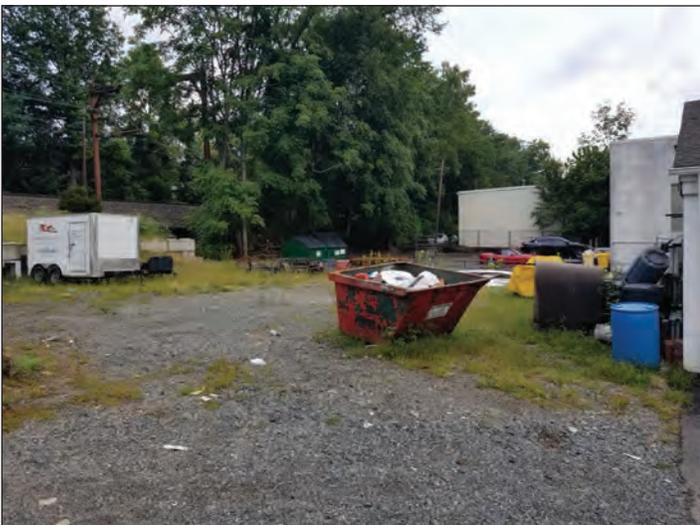
Figure 5: Miscellaneous outdoor storage including randomly placed dumpster.

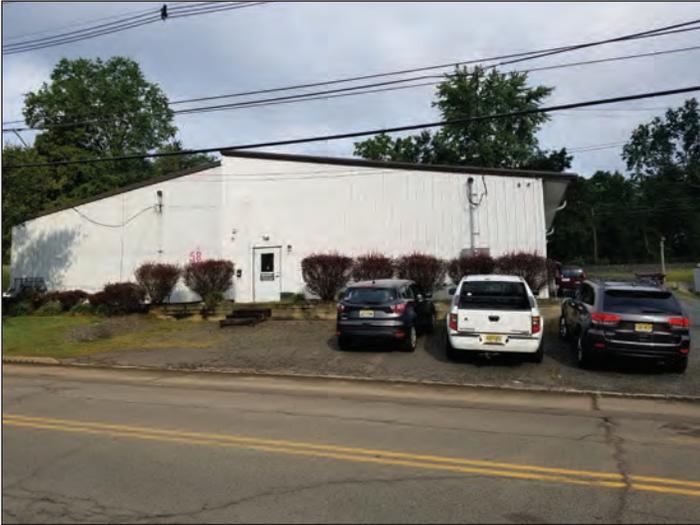
Figure 1: Front-in / back-out parking in front yard onto River Road.

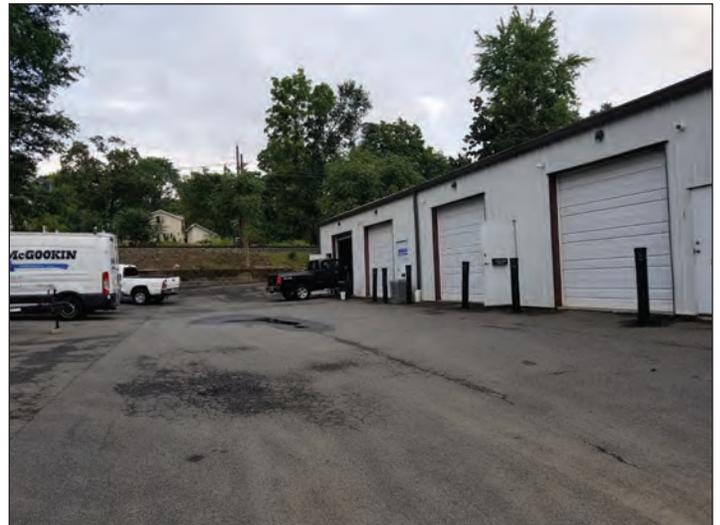
- Figures 4 to 6 show wet spots and puddles forming in the southern parking area. DMR observed a storm drain at the top of the driveway from this parking area, but did not see any storm drains in this parking area to safely and effectively remove water from the area. Consequently, it is likely that this parking area will need frequent repair and re-pavement. (Criterion "d", faulty & obsolete site layout, Section IV.5)

Figure 4: Parking and loading area, with visibly damp pavement and pooling water.

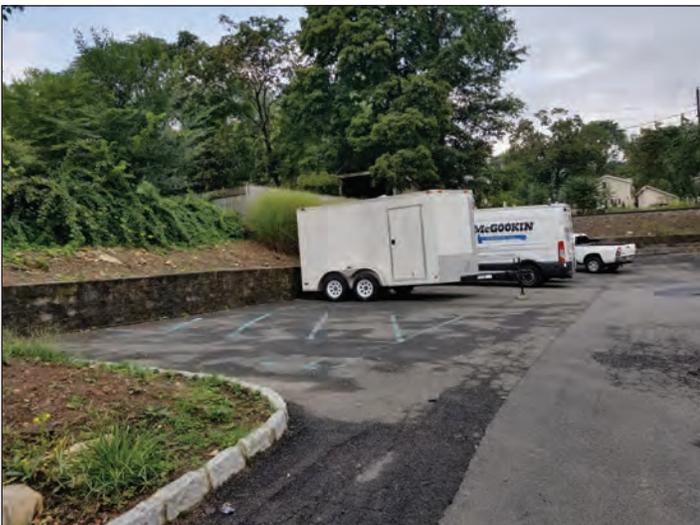
Figure 5: Parking spaces adjacent to retaining wall.

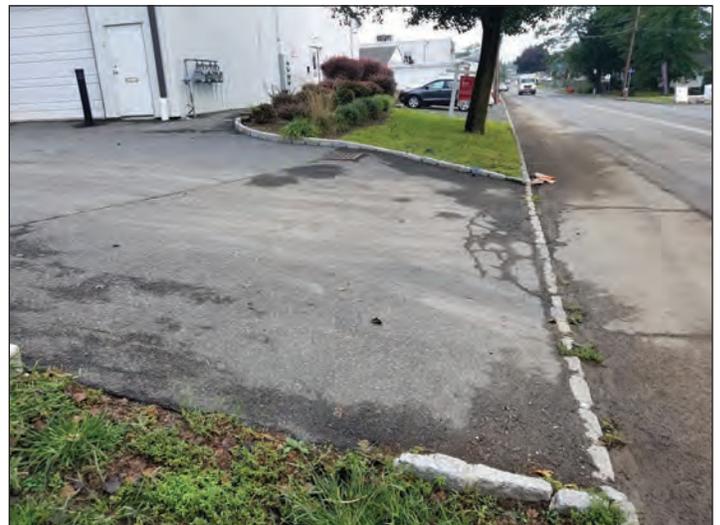
Figure 6: Driveway apron in fair condition.

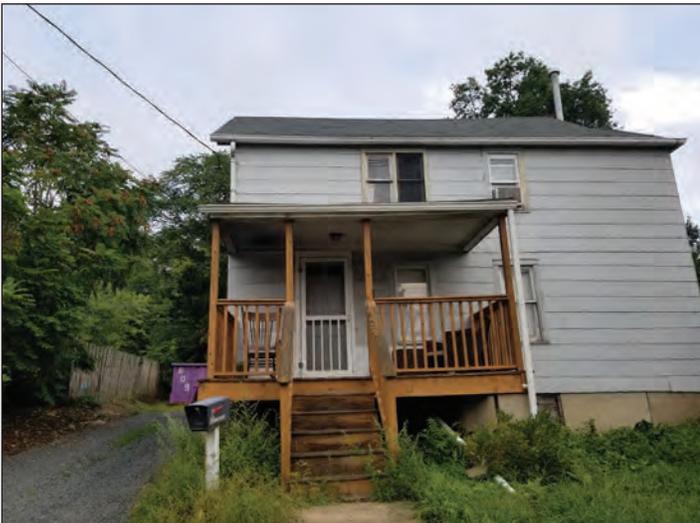
Figure 3: Front porch from River Road. Slight bend in porch roof and supports is visible.

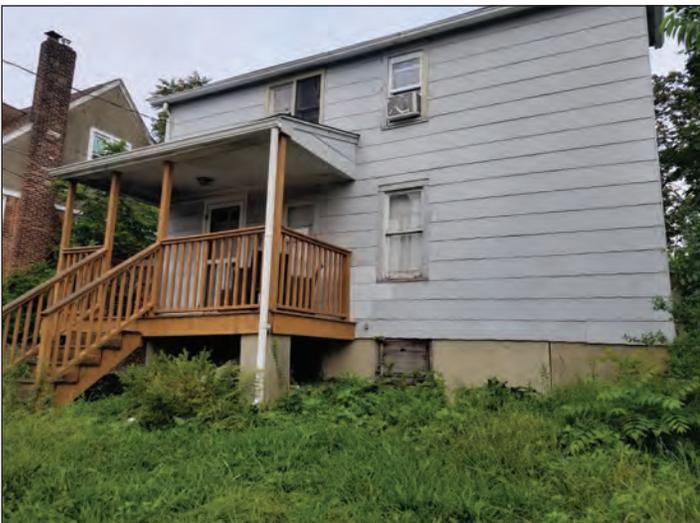
Figure 5: Northeast corner of dwelling. Slight rotting of wood window treatments.

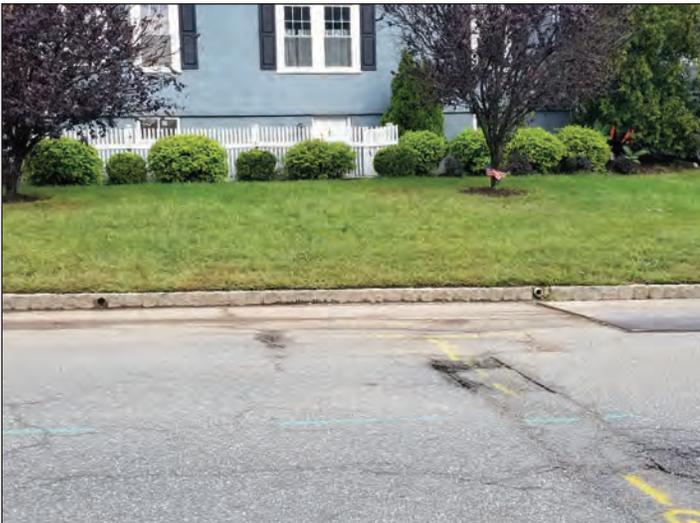
Figure 3: Stormwater outlets releasing into River Road cartway.

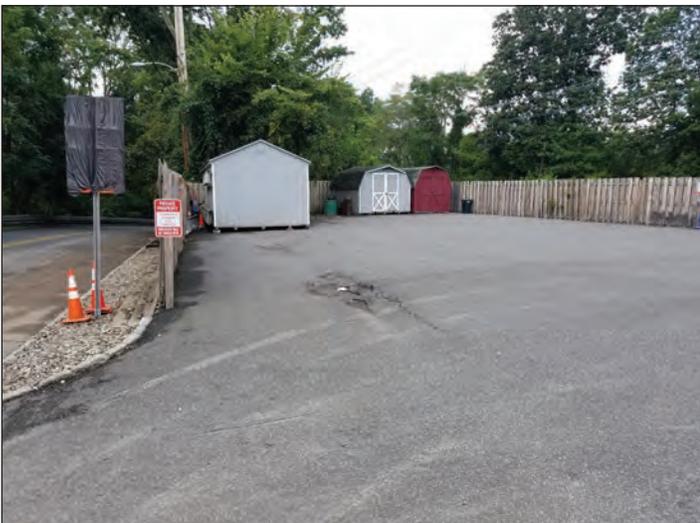
The building exterior is in good condition. The south parking lot is generally in good condition except that two trench-like holes were forming at the time of DMR's visit. The north-side driveway is also in fine condition except that the driveway apron is deteriorated and, based on the amount of water penetration visible during DMR's site visit, is likely exposed to a significant amount of stormwater, which would accelerate its rate of deterioration compared to the rest of the driveway.

Figure 5: Storage sheds at rear of parking lot. Visible holes and depressions in parking surface.

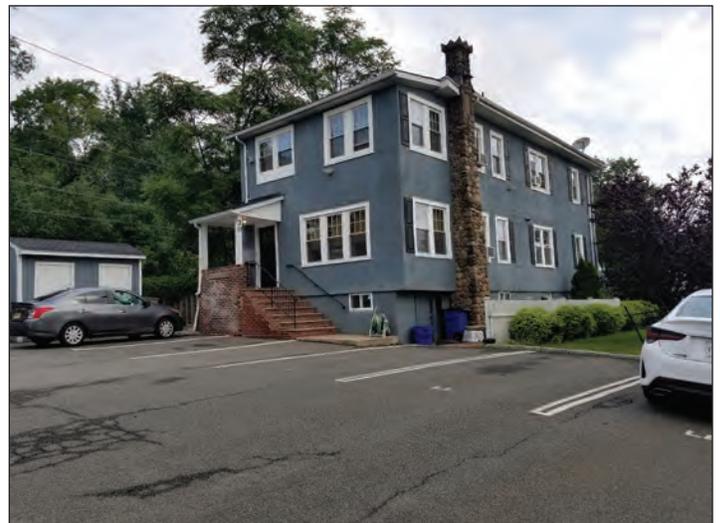
Figure 6: Southeast corner of dwelling. No ADA accessible entrance.
