Preliminary Investigation for Determination of an Area in Need of Redevelopment and Rehabilitation

Block 134, Lots 1-7 & 26-28; Block 135, Lots 1-8 & 13-14; Blocks 136-140 (All Lots)

Prepared For:
Borough of Chatham
Morris County, New Jersey
July 2021

Prepared By:
DMR Architects

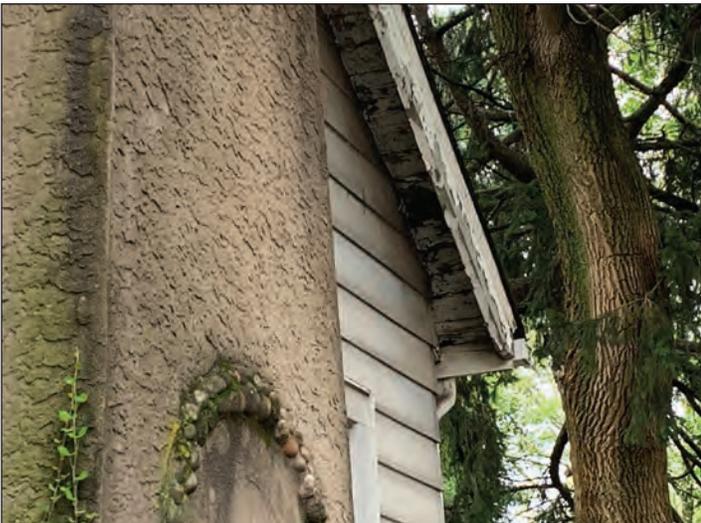
Figure 3: Faded paint and potentially rotting wood on dwelling eaves and siding.

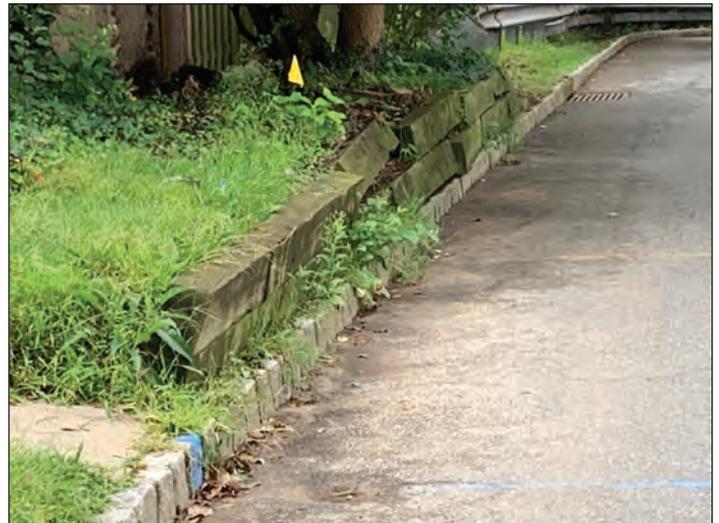
Figure 4: Collapsing and displaced wood railroad ties with retaining wall function.

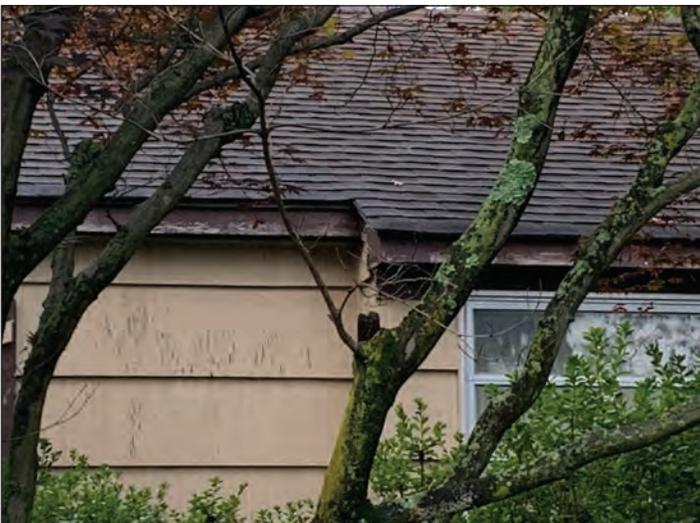
DMR could make out very little of the buildings or other characteristics of the site due to the dense plantings throughout. The only noticeable defect is potential rotting of wooden elements of the house as seen on Figure 5.

Figure 5: Faded paint and possible wood rotting on roof eaves and siding.

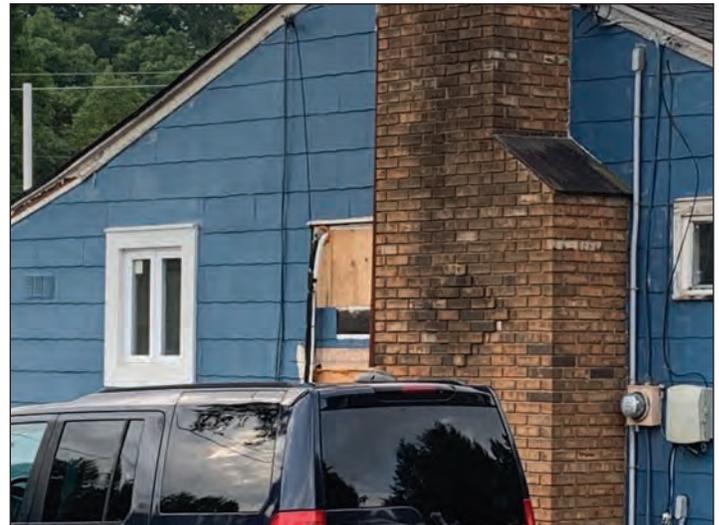
Windows and other wall penetrations on the office building are covered in plywood, which do not promote acceptable insulation. Additionally there is visible rot on some of the wood elements of the building facade and window treatments. (Criterion "d", dilapidation)

Figure 4: Another view of boarded-up windows/penetrations. Possible rotting wood on roof rake and window frames.

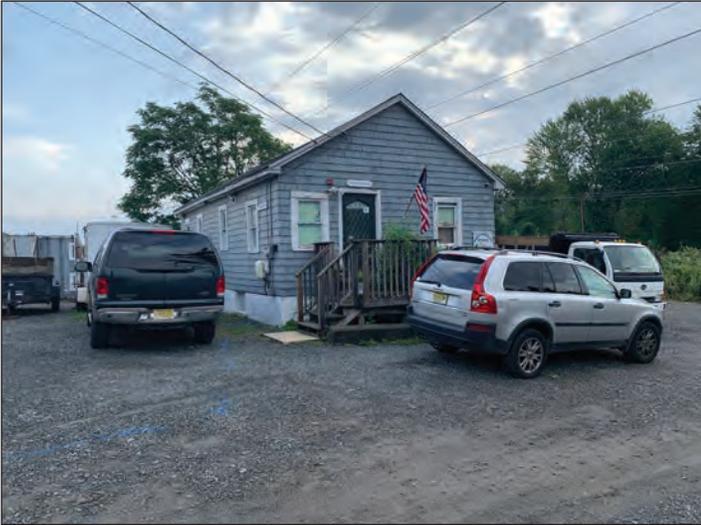
- The wood siding materials and window treatments on the office building are rotting and wearing away. This can affect insulation and permit intrusion of water and moisture into the structural parts of the building or the work spaces therein.
- Windows also appear from the outside to be blocked or boarded up, which may be a fire safety hazard as well as an obstruction of access to natural air and light.
- The combination of the above conditions make the building unsuitable for occupancy. (Criterion "a")

Figure 1: Office building on Lot 2. Unmarked parking taking place on front and side. No ADA accessible entrance.

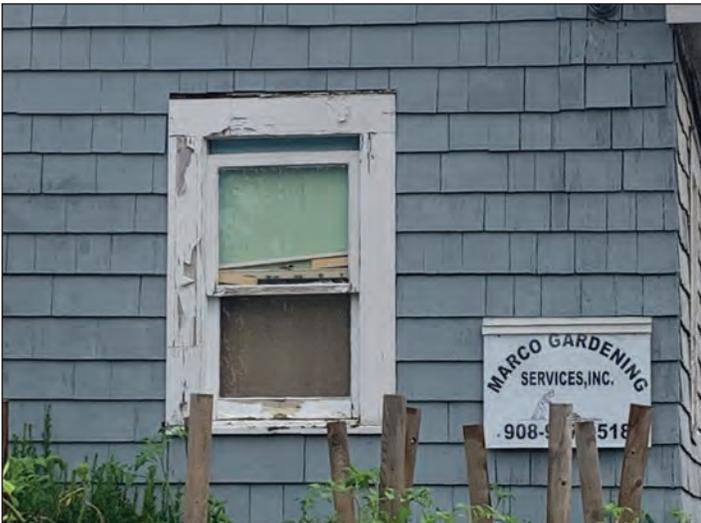
Figure 3: Rotting and damaged window.

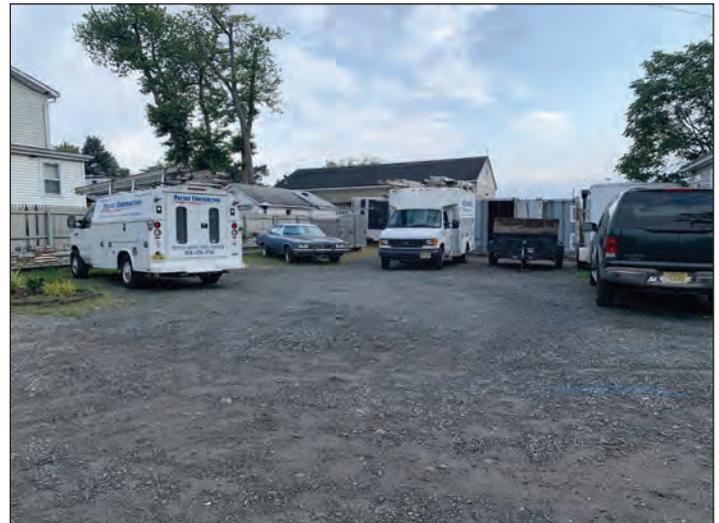
Figure 4: Miscellaneous and unmanaged parking and storage adjacent to office building.

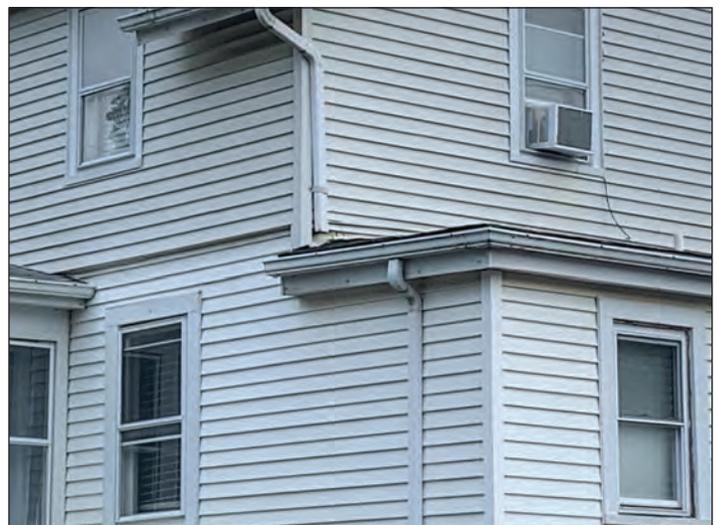
Figure 6: Roof leaders on dwelling.

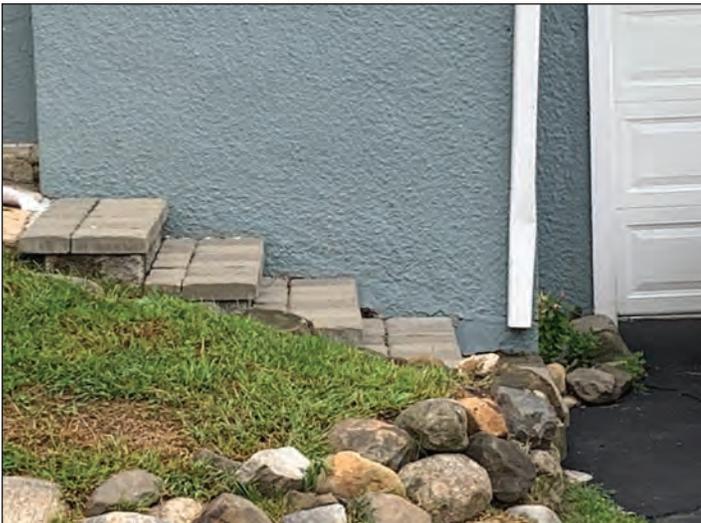
- Downspouts open onto paved surfaces immediately adjacent to the building walls, which as previously discussed in this report creates hazards such as icy conditions that can cause people to slip, and accelerated wear of paved surfaces, wall materials, and building foundations. (Criterion "d", faulty design, Section IV.4)
- There appears to be no drainage in the commercial parking and storage area at the rear of the lot. (Criterion "d", faulty design, Section IV.5)

Figure 3: Downspout releasing onto steps, creating possibly slippery conditions during freezing weather.

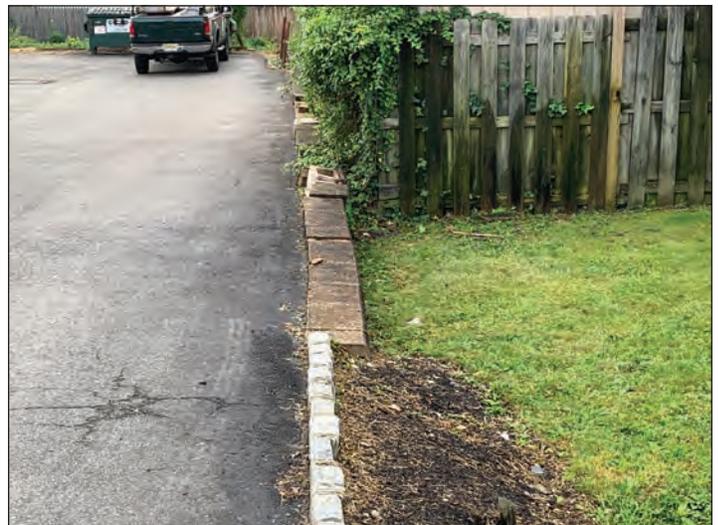
Figure 6: Change in curb material.

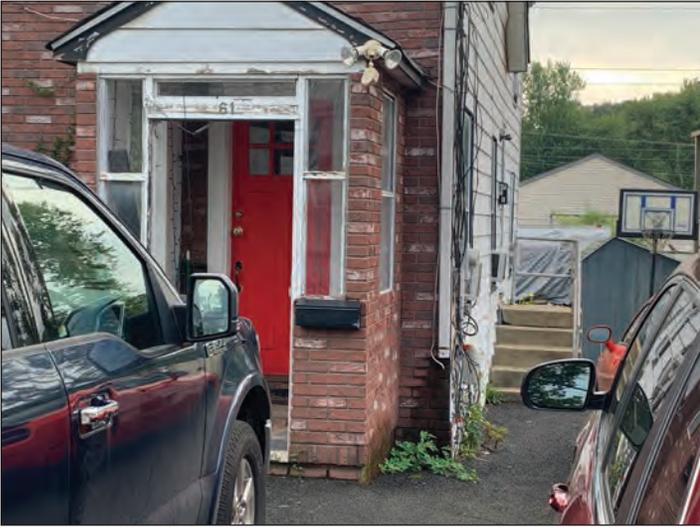
- There is a rear concrete deck behind the dwelling that is elevated at least two feet above grade but has no stair or other ramp access, or railings to prevent falls. The consequence of this could be persons falling off the deck and injuring themselves. (Criterion "d", faulty design)
- A downspout on the front building wall opens partway down the front of the building, causing water to soak the wall. This is likely to increase the rate of deterioration of the building and possibly the foundation over the long term. See Figure 2 (Criterion "d" per Section IV.4)

A retaining wall and fence along the St. James Street side lot line and a rear wooden privacy wall at the rear lot line of the property are failing. See Figures 2 through 6. If not corrected, this could cause personal injury or property damage. (Criterion "d", dilapidation)

Figure 2: Downspout opening onto building wall, which is visibly wet from a recent storm.

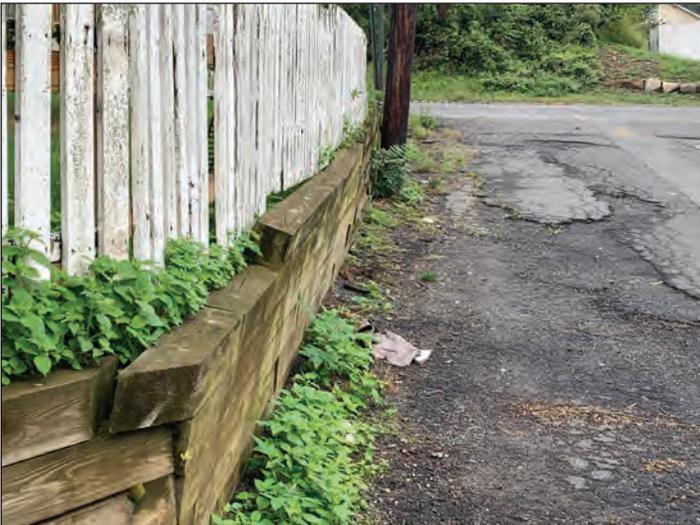
Figure 4: Close-up of displaced retaining structures. Mild wood rotting visible on fence.

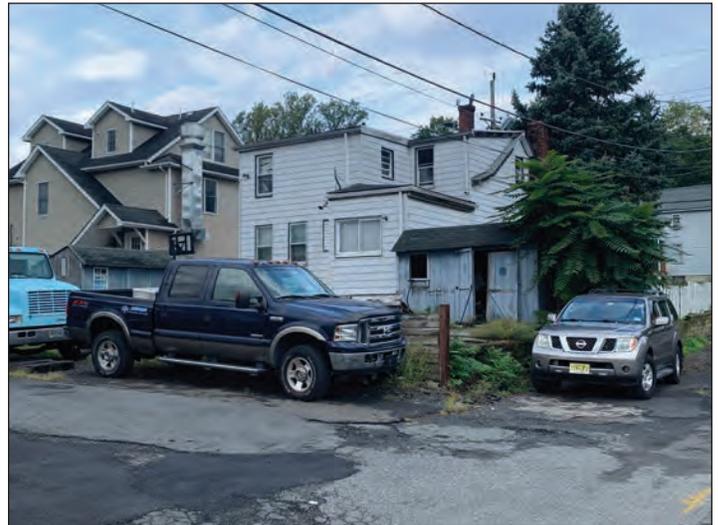
Figure 5: Cars parked in rear of property.

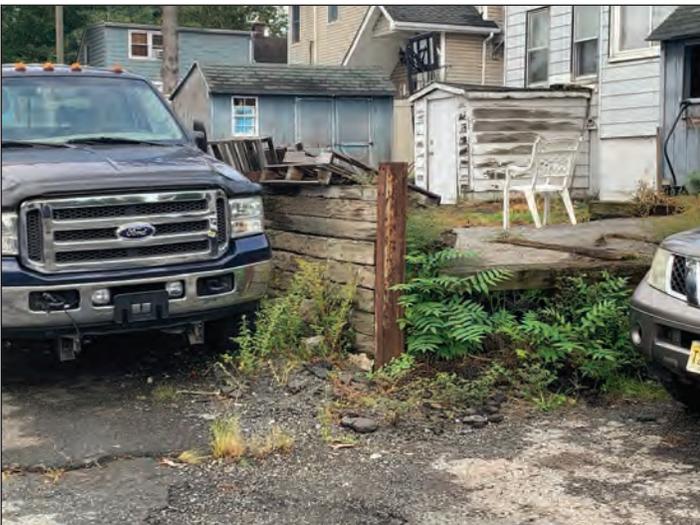
Figure 6: Close-up of rear wooden wall. No stairs from driveway to rear deck.

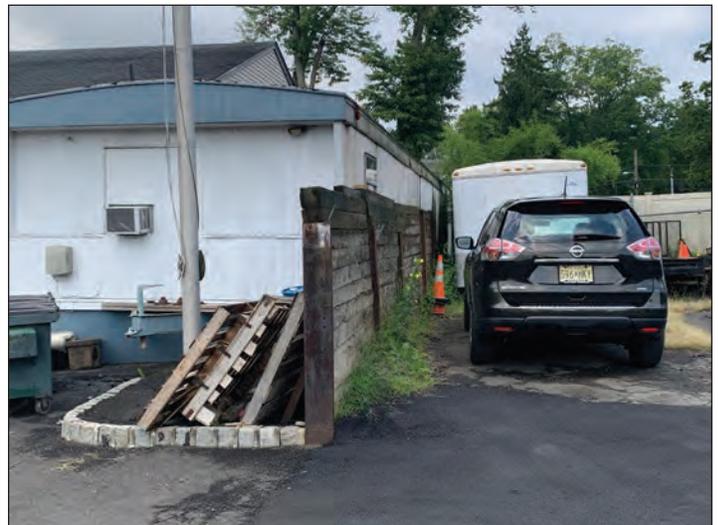
Figure 7: Rear property wall. Top of wall beginning to warp.

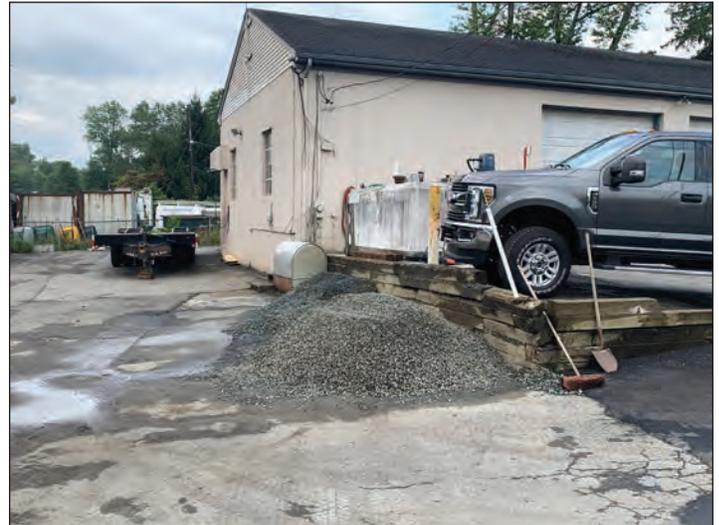
- The office section of the main building is not ADA accessible. (Criterion "d" per Section IV.7)
- There is no protective barrier surrounding the parking space shown in Figure 2, which creates a safety hazard. (Criterion "d", faulty design)

- Parts of the parking and circulation areas are showing signs of water damage due to inadequate drainage. See Figures 1, 3, 4, and 5. (Criterion "d", Section IV.5)
- A retaining wall supporting a parking space raised approximately 3 feet above grade is beginning to collapse. See Figure 2. (Criterion "d", dilapidation)

Figure 2: Gravel pile in front of collapsing retaining wall. Outdoor oil tank and other exterior equipment.

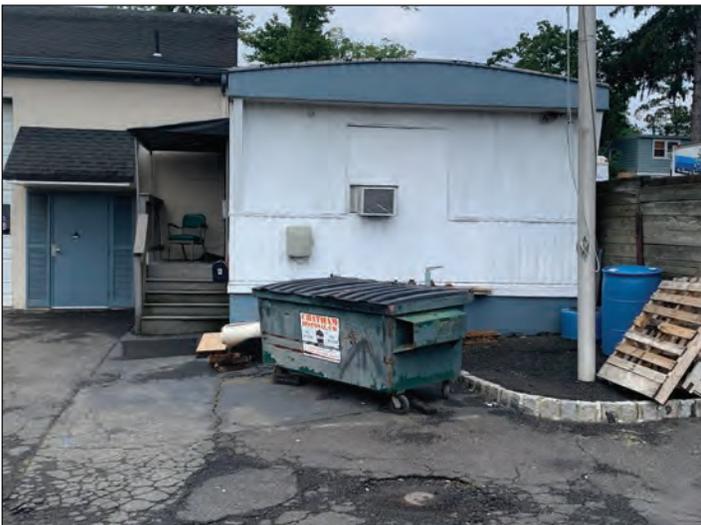
Figure 3: Dumpster located near office entrance.

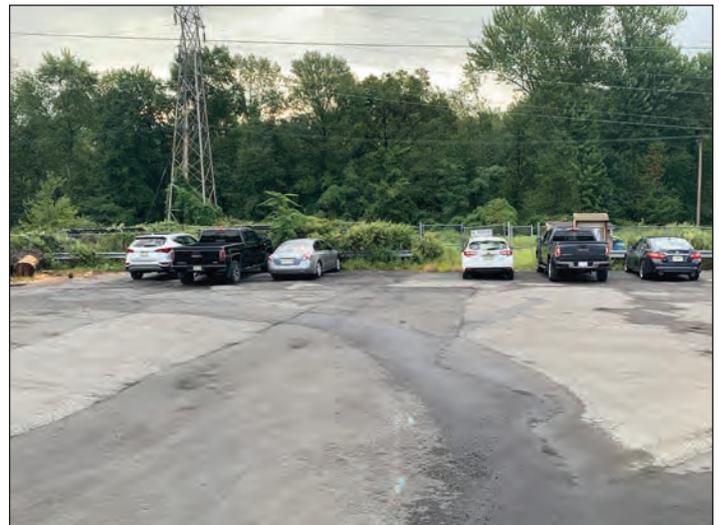
Figure 4: Cars parked along property line of municipal tract.

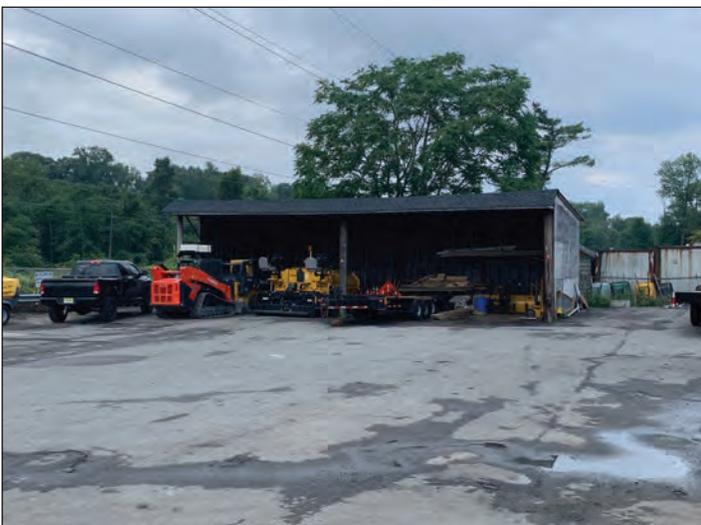
- Open outdoor storage and open storage sheds without fences or gates for screening or security purposes harms quality of life by forcing the public and residents to view operations and storage and fails to prevent trespassers from accessing equipment which is a potential safety and health hazard. (Criterion "d", faulty design, lack of security, Section IV.8)

Figure 5: Open storage and parking shelter.

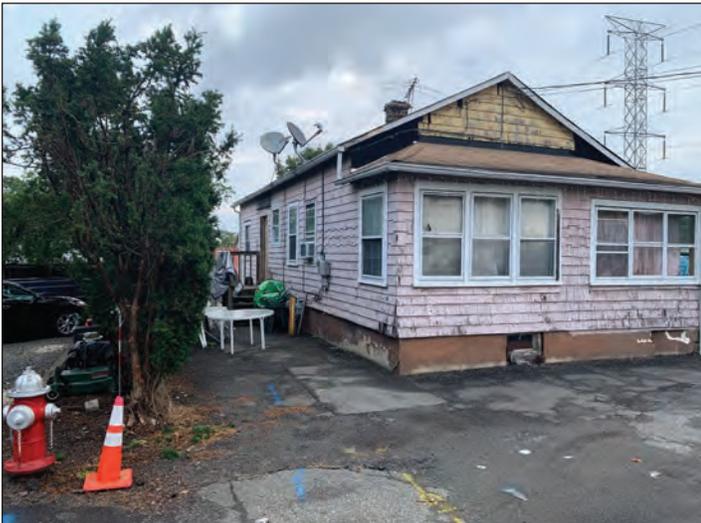
Figure 3: Other view of building with additional rotting wood features, damaged foundation.

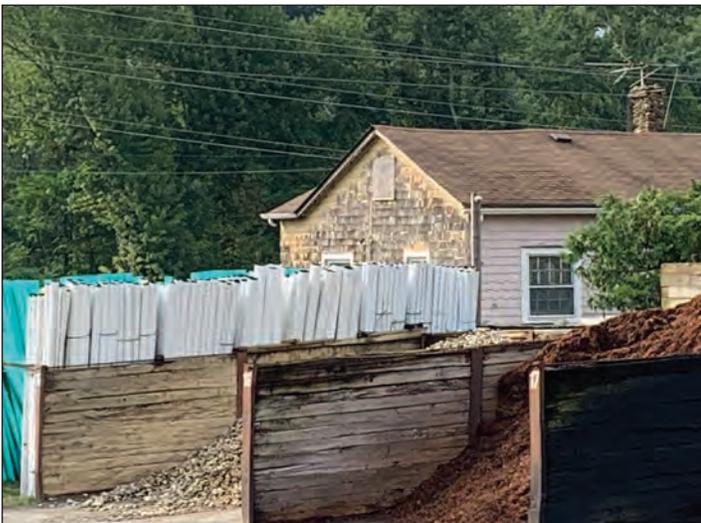
Figure 5: Rear of building visible from River Road. Deteriorated wood siding and bowing roof visible.

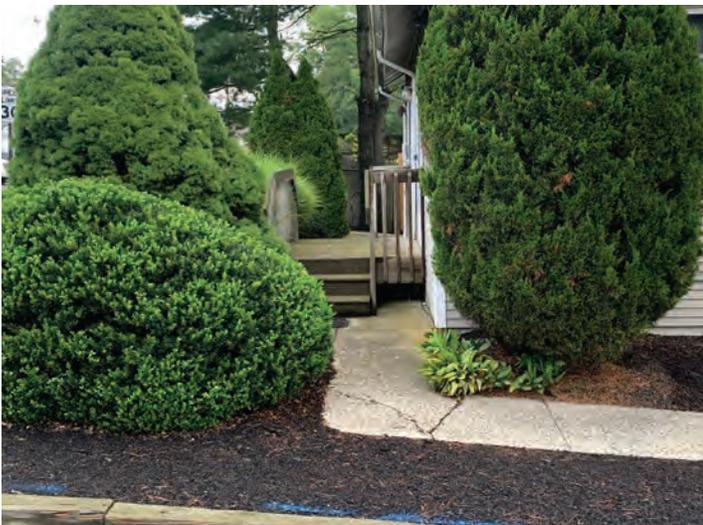
Figure 5: Steps to front entrance.

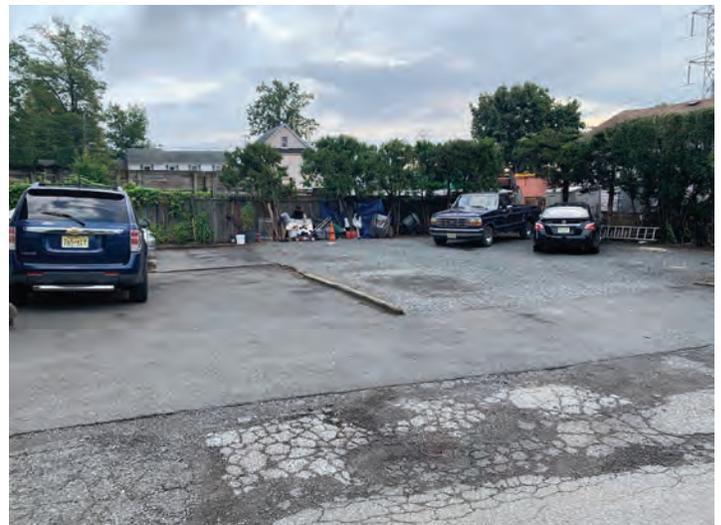
Figure 6: Rear parking area. Partially paved, partially gravel.

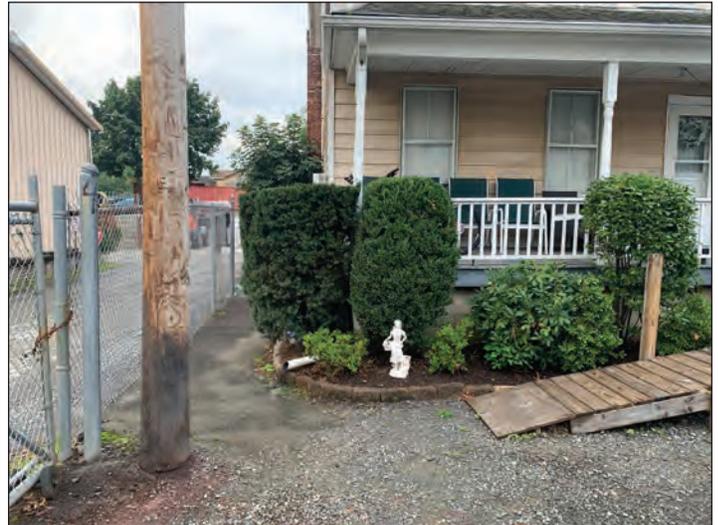
Figure 2: Front of two-story building on Lot 5. Stormwater collected from roof released away from building.

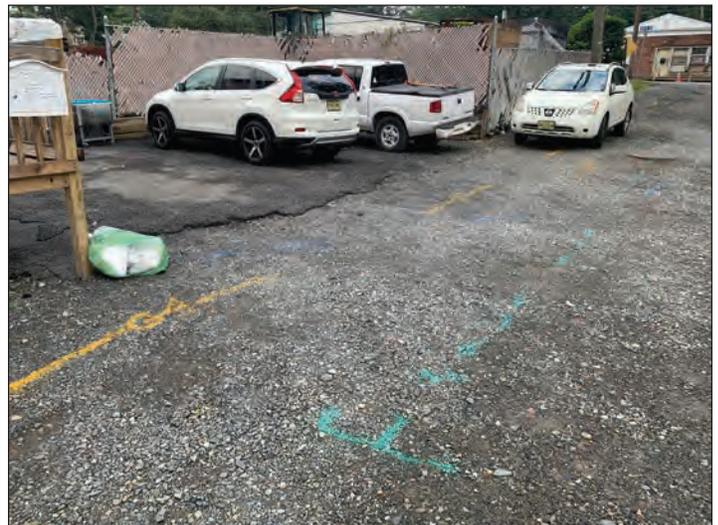
Figure 4: Cars parked on site and in Perrin Street.

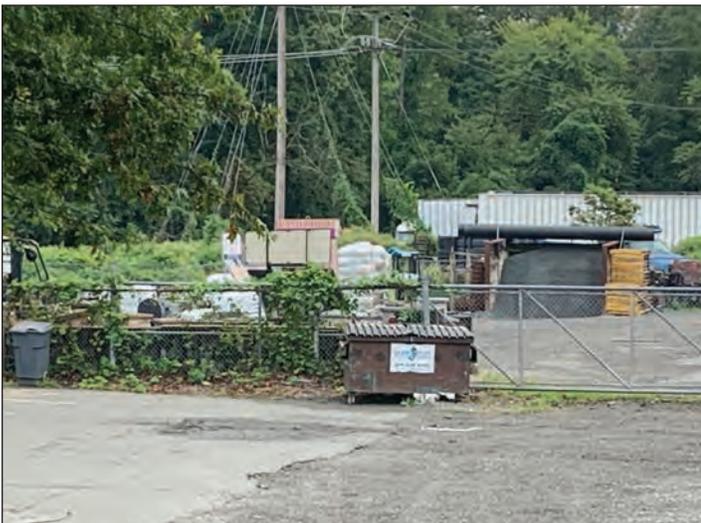
Figure 9: Close up of outdoor storage in Perrin Street right-of-way between Block 139, Lots 6 and 7, and Block 140, Lots 2 and 3.

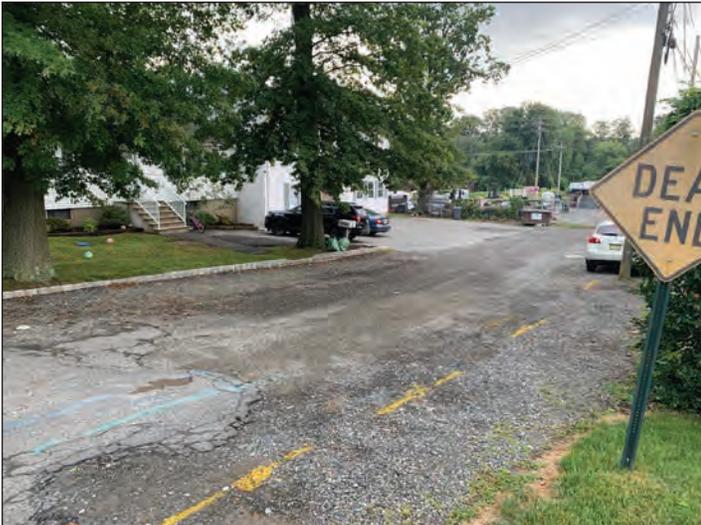
The property itself appears to be in acceptable condition; however, Perrin Street cartway is deteriorating, as is visible in Figures 1, 3, and 4.

Figure 1: Perrin Street building entrances and parking. Asphalt walkway from door is not connected to street.

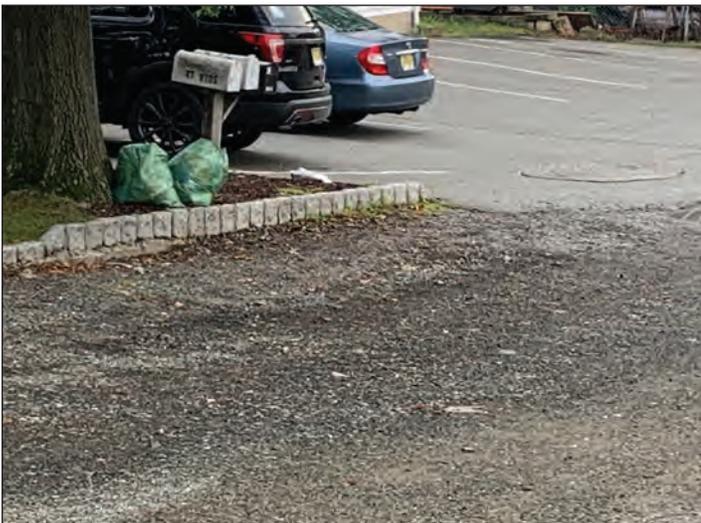
Figure 3: Gravel surface of Perrin Street.

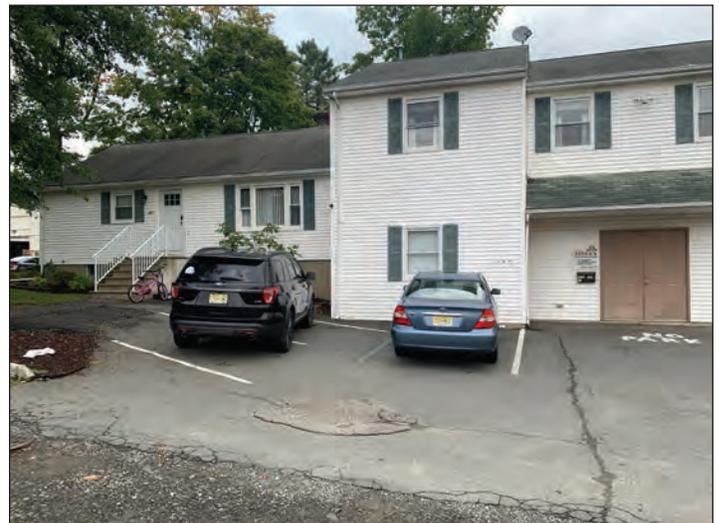
Figure 4: Inconsistent and unclear parking area striping, including a nonconforming ADA parking space.

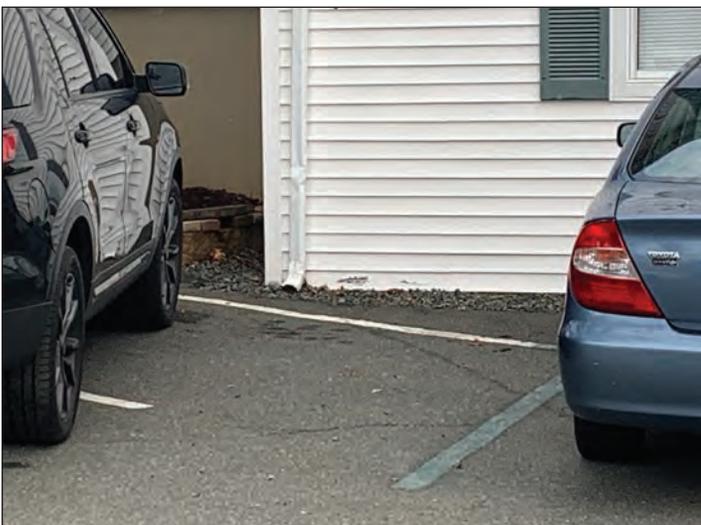
Figure 5: Downspout opening onto parking area near building wall.

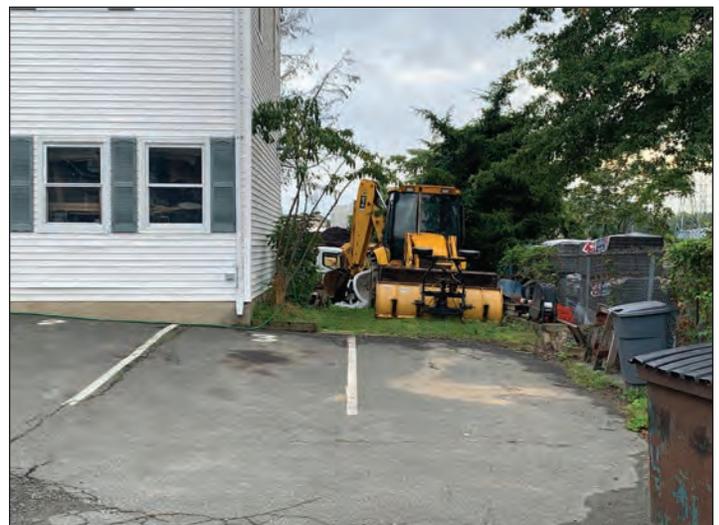
- Construction vehicles and other types of vehicles and equipment are stored on an unpaved surface in the 10-foot wide rear yard between the building and the rear property fence, and in such a manner that the vehicle can be blocked in by cars parked in the parking lot. This is an unsafe and inappropriate area to store such vehicles, as muddy conditions can reduce traction and vehicles can potentially damage parked cars or the building itself. (Criterion "d", obsolete layout indicated by need to park cars in unpaved side yard due to lack of space in parking area to accommodate contractor use)

Figure 6: Downspout opening onto parking area near building wall. Construction vehicle in rear yard.

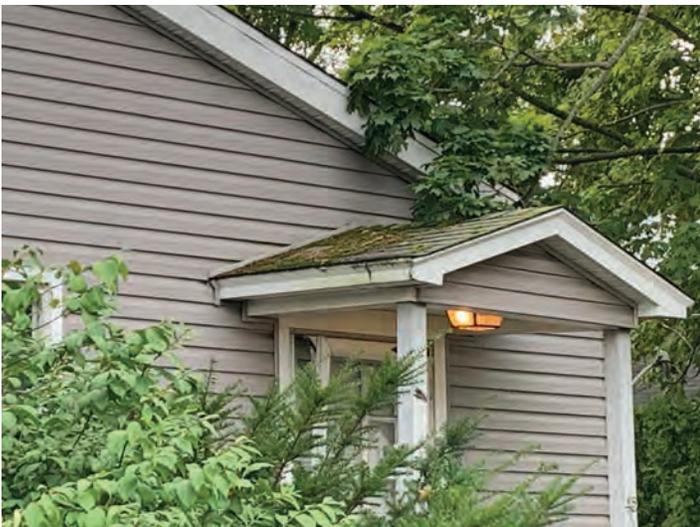
- Moss and other plant material are accumulating on the porch roof. While not immediately harmful, this can cause damage to the roof over time if not cleaned up.
- Any pavement in the driveway and parking area is deteriorated and resembles gravel. DMR could not determine from the street whether there are storm drains in the parking area, which is downhill from River Road and therefore is likely to accumulate stormwater if there is inadequate drainage.

Figure 2: Moss and plant material accumulation on roof.

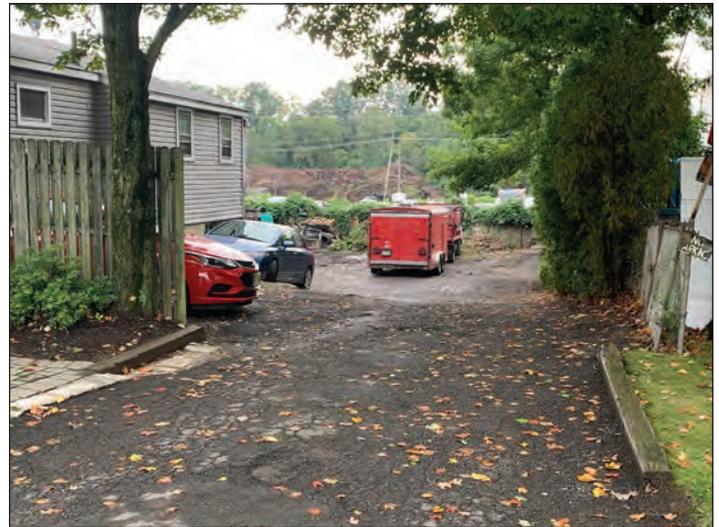
Figure 3: Side and rear parking area with varying grade.

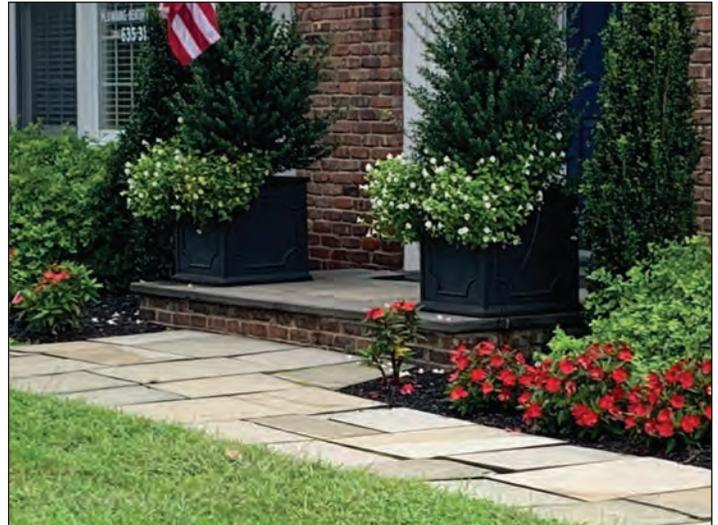
Figure 2: Raised entrance area.

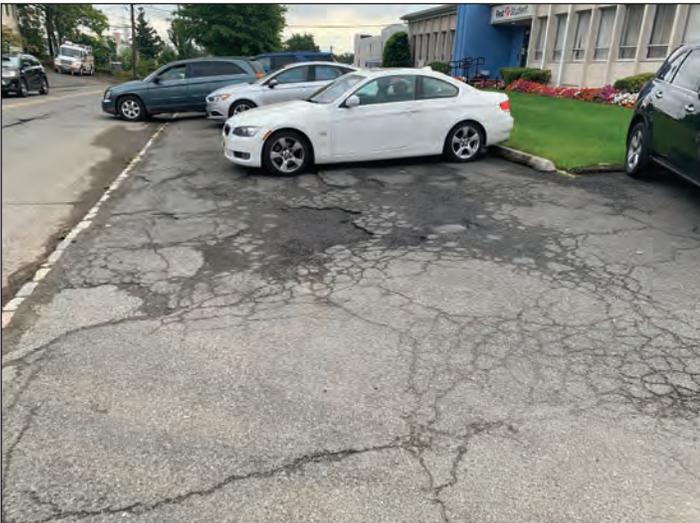
- Back-in / Back-out parking in the front yard of Lot 10. See Figures 9 and 10; (Criterion "d" per Section IV.1)
- Lack of site lighting in parking and storage areas across site; (Criterion "d" per Section IV.6)

Figure 9: Front yard parking requiring cars to directly back out to or back in from River Road.

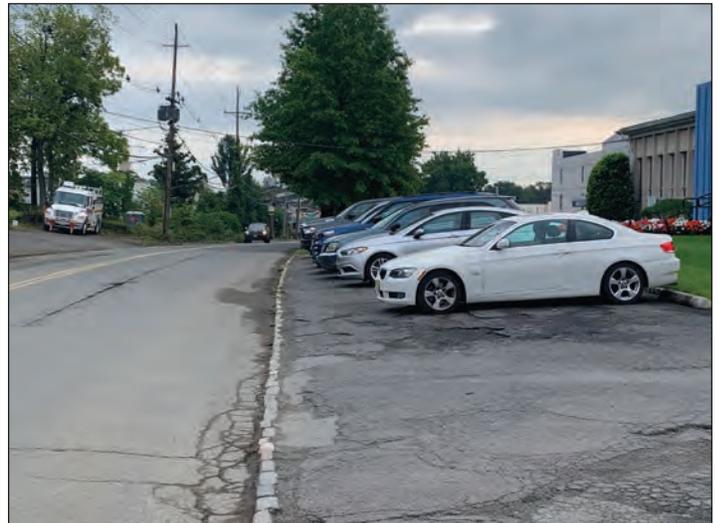
Figure 10: Front yard parking requiring cars to directly back out to or back in from River Road.

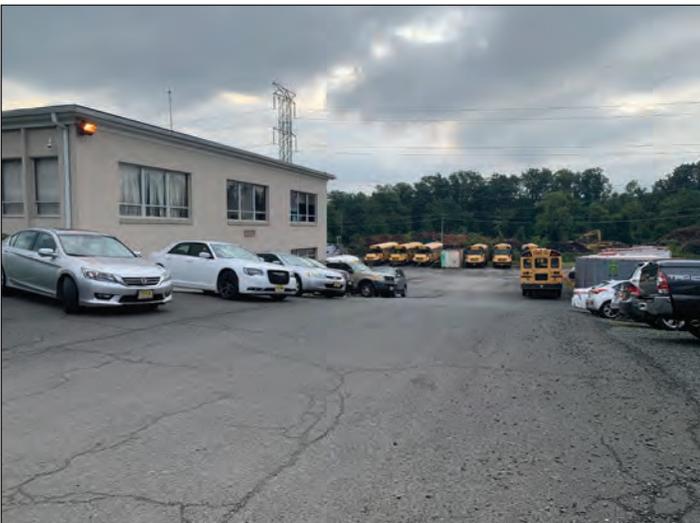
- Angled parking in south side yards of Lots 9 and 10 require cars to turn around in the rear yard in order to safely exit the property. See Figure 11; (Criterion "d" per Section IV.2)

Figure 11: Parking in side yard of Lot 10.

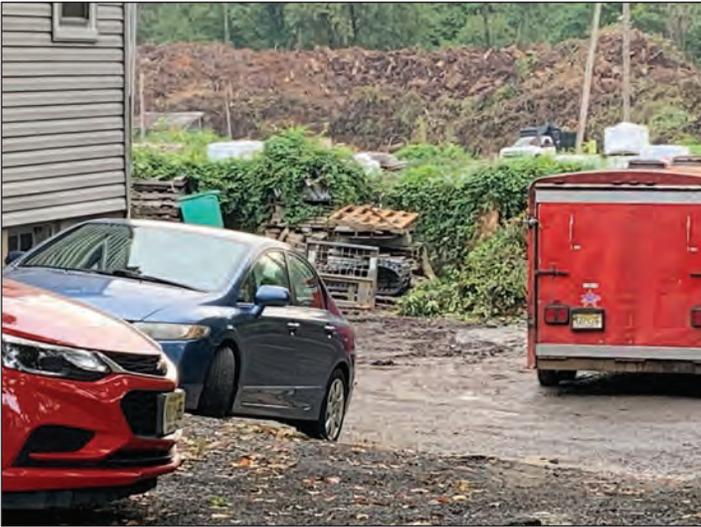
Figure 7: Debris piles in distance on Block 140 Lots 17 and 7.02.

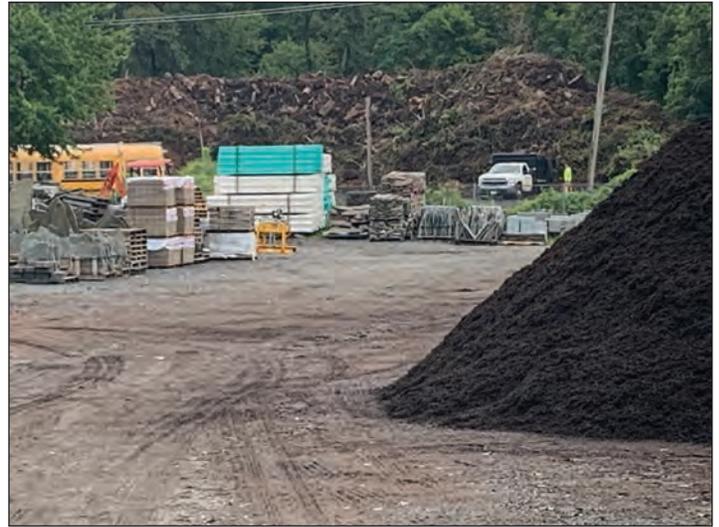
Figure 8: Debris piles & outdoor storage on Block 140 Lots 17 and 7.02.
